DETAILED GEOLOGIC INVESTIGATION OF DAM SITES

State Texas County Caldwell ; 1/4 Sec. 1/4, T 1 R 1 ; Watershed Quadrangle  
Subwatershed Plan Creek Fund class (FP-2, WP-1, etc.) Site number 21 Site group II Structure class A  
Investigated by Henry H. Brown Equipment used Falling 1500 Date 7/23/61  
(signature and title) (Type, size, make, model, etc.)

#### PLUM CREEK, SITE 21

#### CALDWELL COUNTY, TEXAS

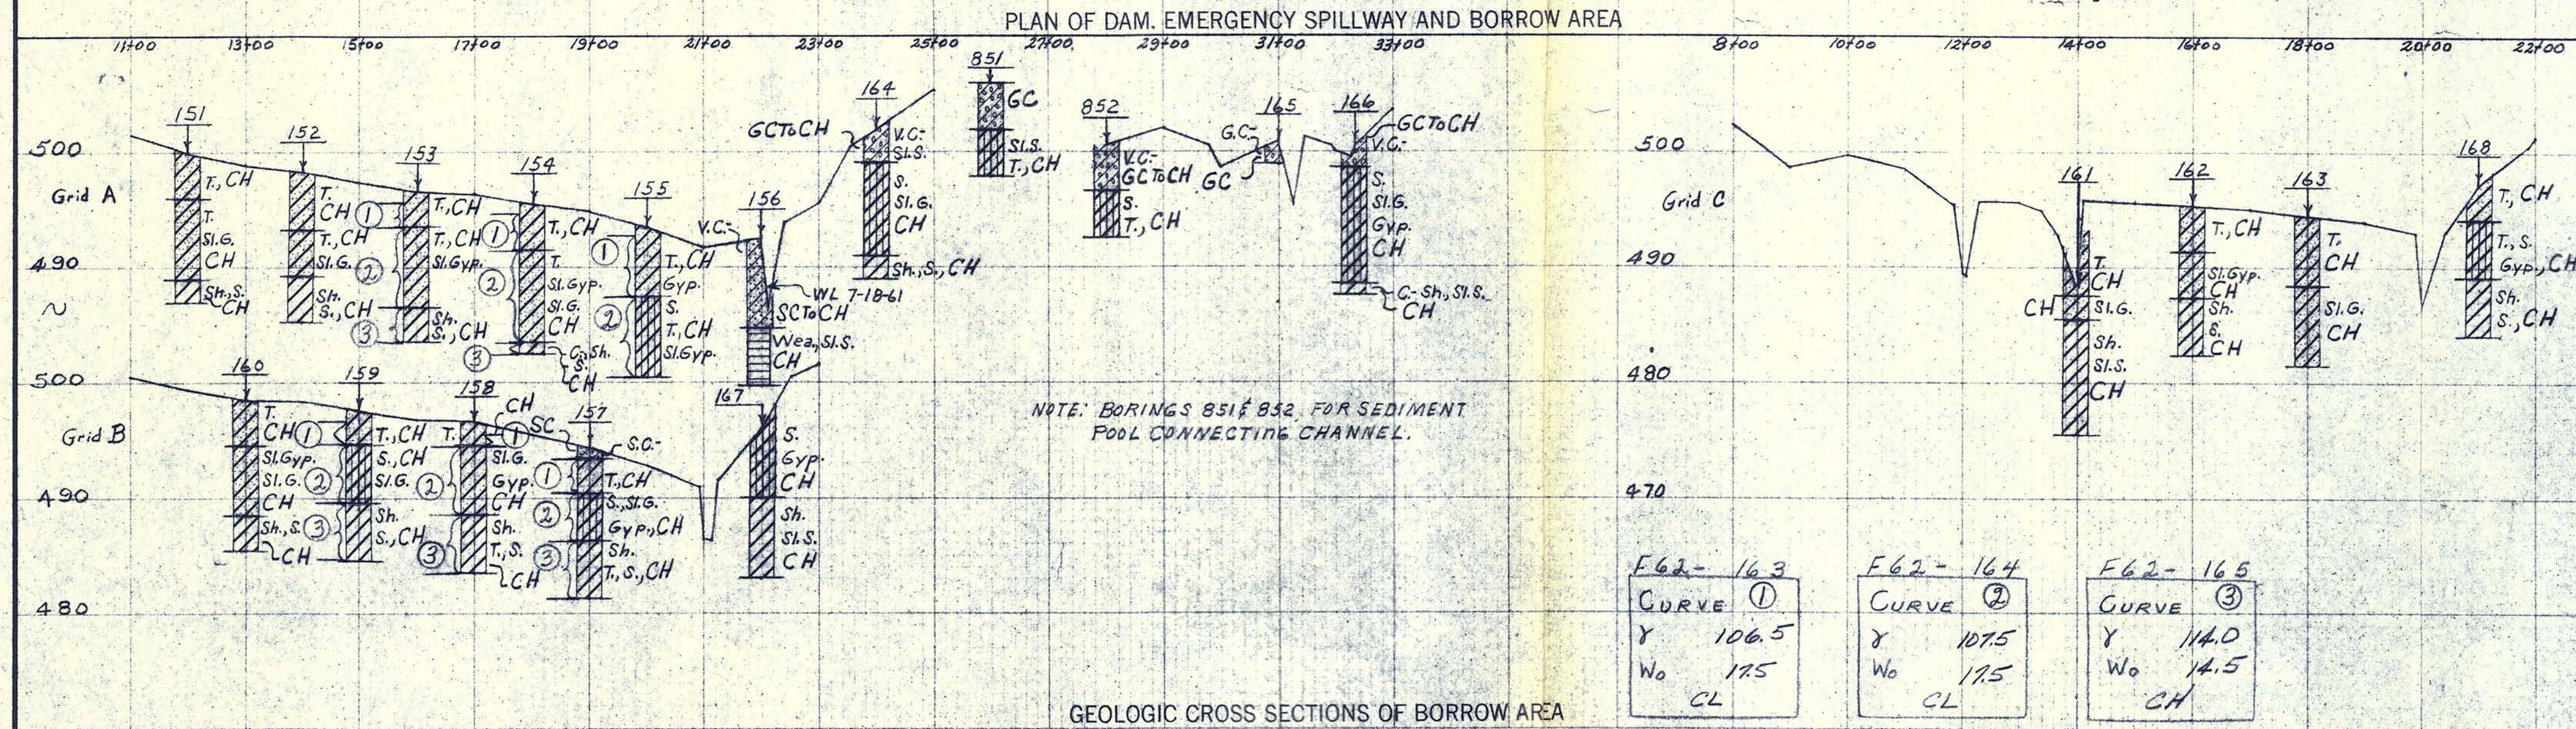
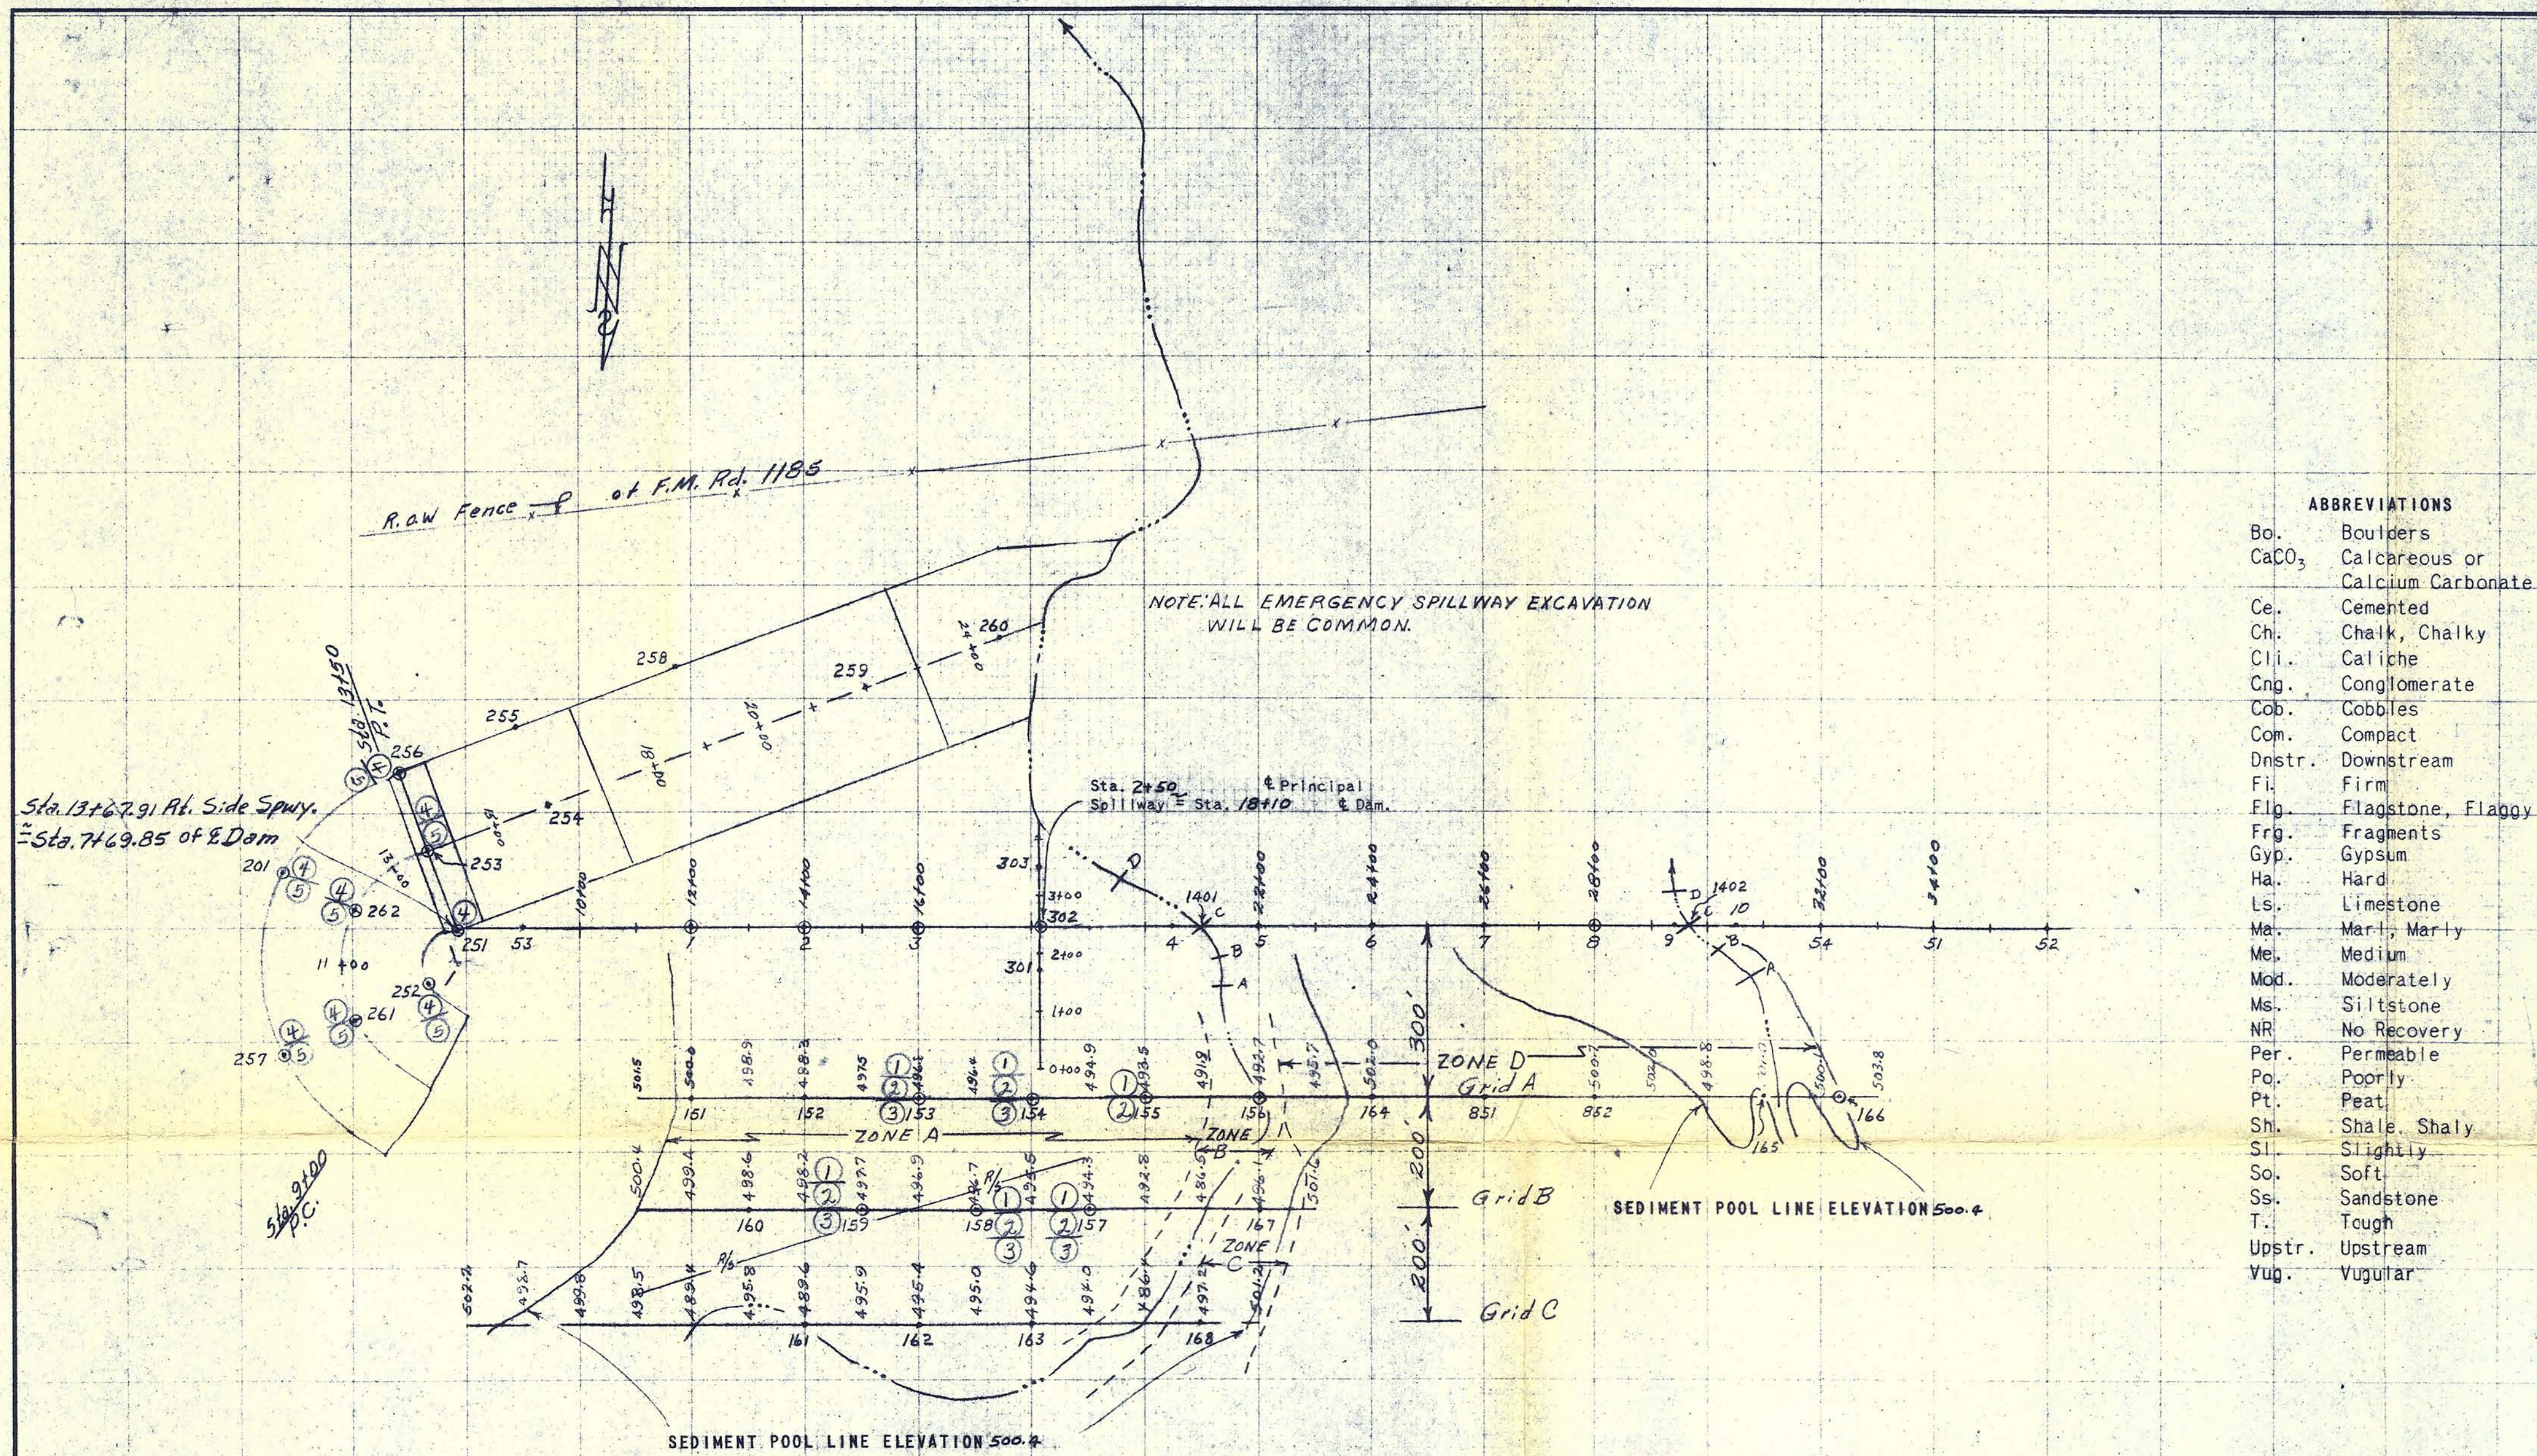
##### PLAN OF DAM, EMERGENCY SPILLWAY & BORROW AREA

The borrow area was divided into four areal zones, mainly due to the presence of different types of materials in the surface horizon.

Three soil horizons are present in areal zone "A".

The surface horizon consists of sandy CH material.

The second horizon is a laminated sandy CH material containing slight amounts of gravel and slight to moderate amounts of gypsum.

The third horizon is a laminated, sandy, shaly clay.

Areal zone "B" is present along the left stream channel and two material horizons were present.

The top horizon was a laminated SC-CH material.

The second horizon was weathered shale.

A high water table was found in this zone as shown on the grid sheets.

Areal zone "C" contains three material horizons which are very similar to those found in areal zone "A". Reference should be made to the description of zone "A" materials.

Areal zone "D" also contains three soil horizons.

The top horizon is a GC or GC-CH material.

The second horizon is a laminated, sandy CH material with slight to moderate amounts of gypsum and slight amounts of gravel.

The third horizon is a shaly CH material similar to the third horizon material found in areal zone "A".

**Loading** of borrow materials by making long passes with the scrapers should give compaction curves which will more nearly correspond to Materials Testing Section compaction data on the soils.

Cl materials found in the borrow may be used anywhere in the dam, unless gypsum content is found to be high.

If materials are found to contain high gypsum content they should be avoided or used in the center section of the dam above the sediment reserve elevation.

**SC-CH, GC and GC-CH** materials should be used in the shell of the dam or in the downstream section.

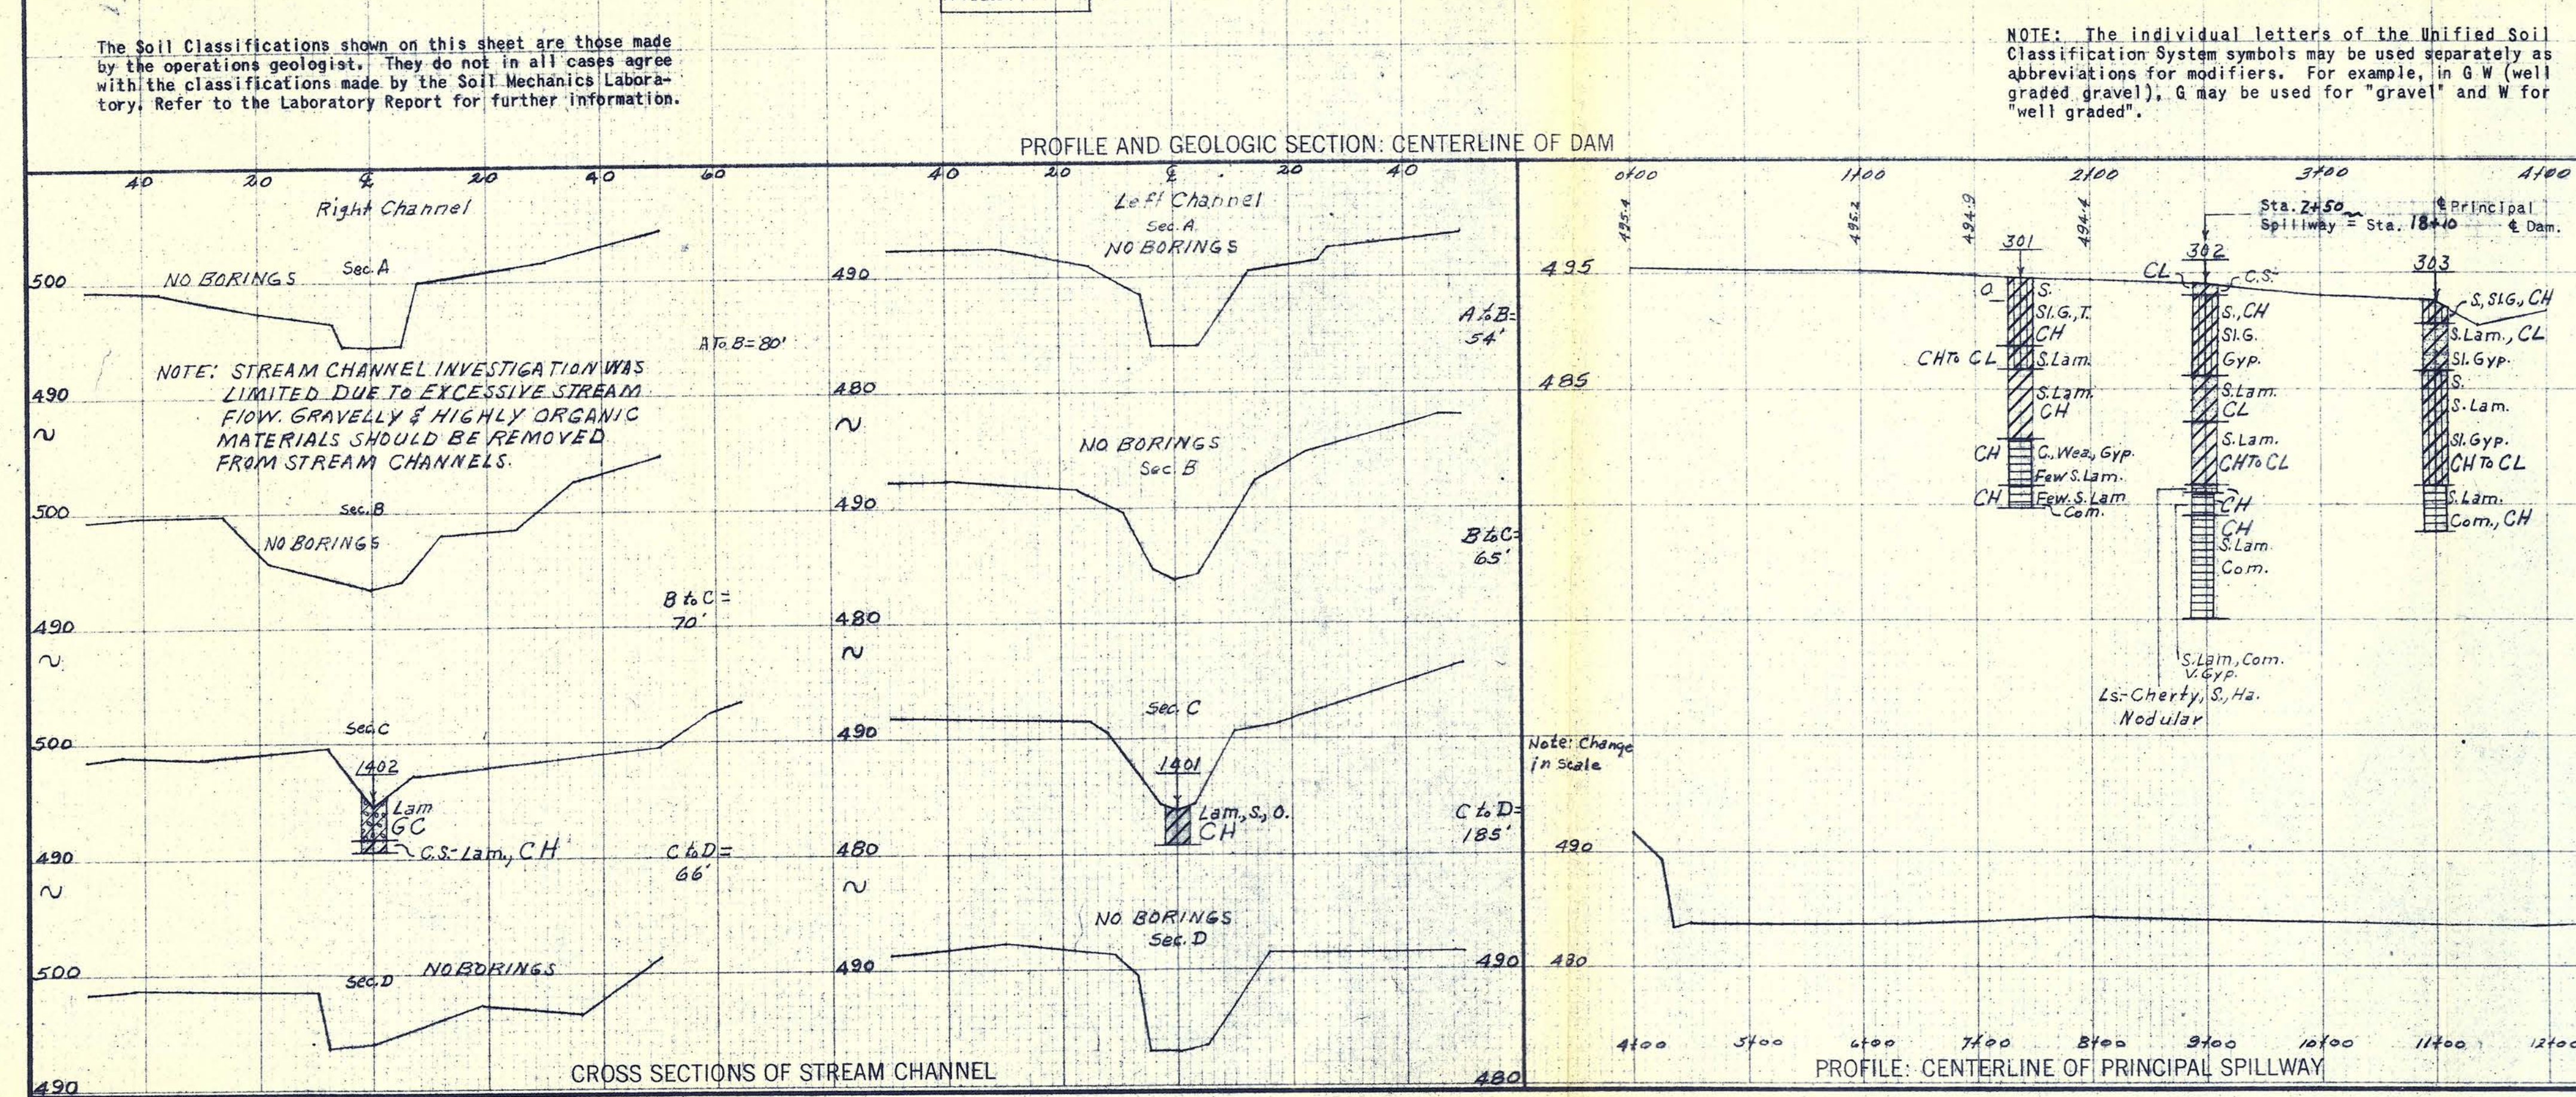
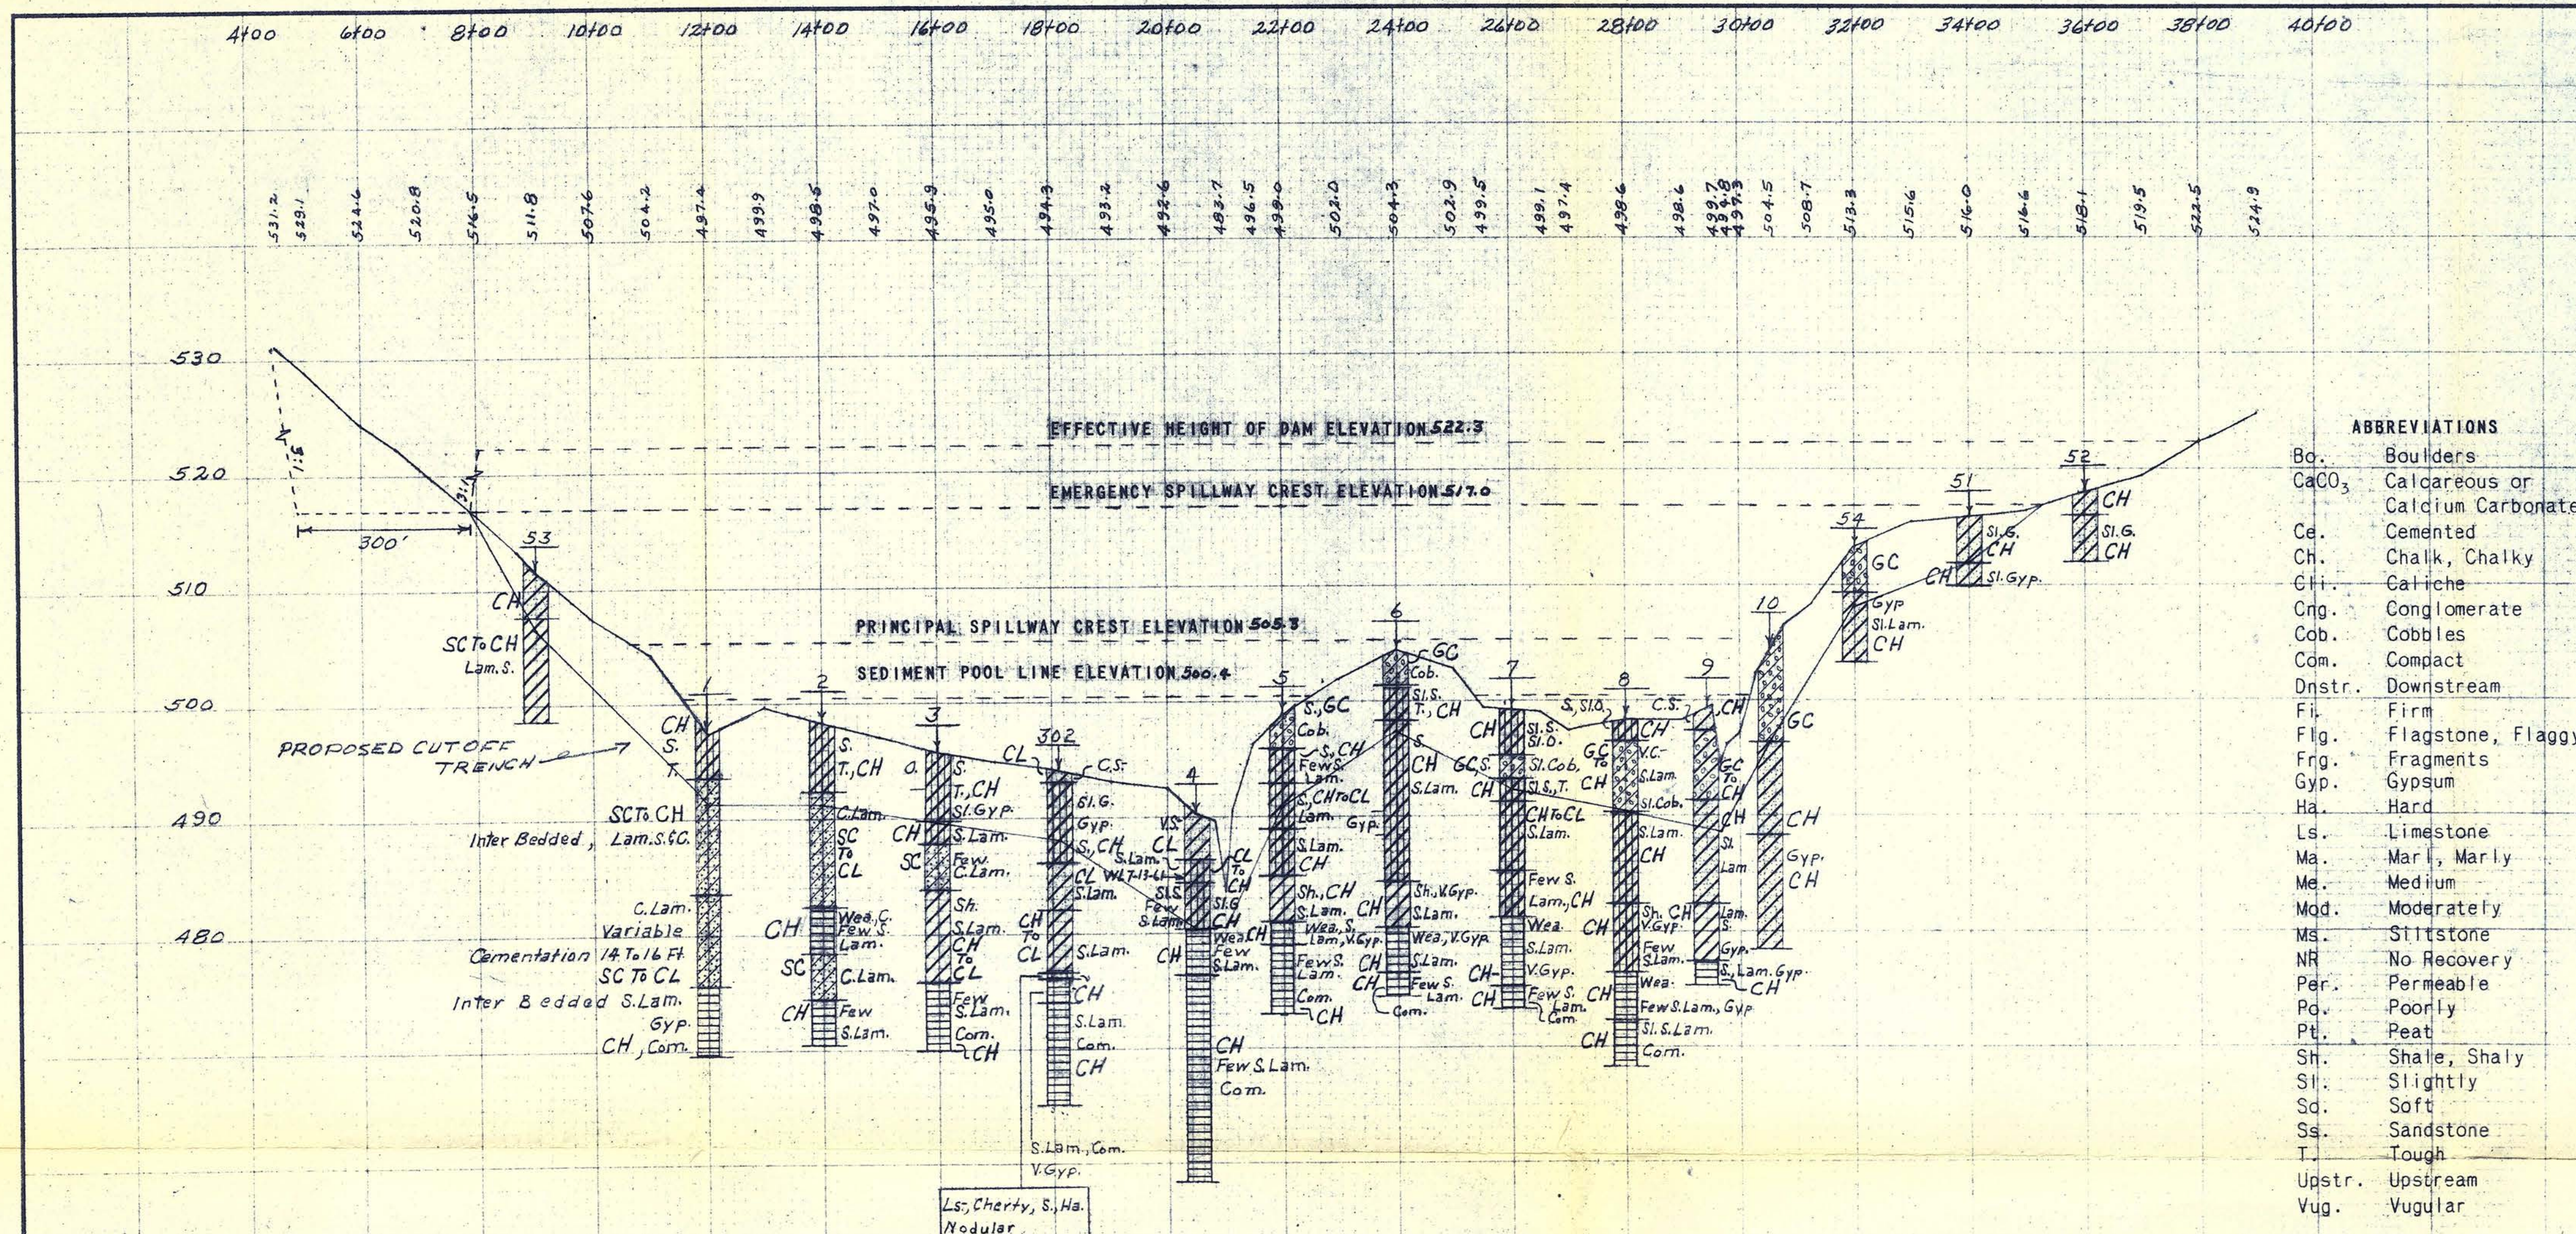
PROFILE OF DAM, CROSS-SECTIONS OF STREAM CHANNELS  
PROFILE OF PRINCIPAL SPILLWAY

The valley floor section to the left of the main stream channel exhibits fairly consistent conditions outlined as follows:

(1) A near surface (upper) horizon of sandy clay (CH) materials rests upon a slightly laminated sand and clay (CH) soil. Below this horizon lies a horizon containing interbedded laminae of sand and clay with the sand laminae increased percentage wise. This horizon also contains gypsum. Parent material consisting of laminated sand and shale lies below the lower horizon.

(2) Exceptions to the generalized conditions above were found in test holes 2 and 3 where horizons of SC materials were penetrated.

(3) To the right of the primary stream channel conditions in the lower horizons were similar to the segment previously described. The upper horizon, however, is composed of SC materials.

The foundation of the abutments is composed of interlaminated sand and clay materials.

Foundation conditions beneath the principal spillway are very similar to those  
described for the valley floor segment of the centerline of the dam.

Two stream channels are present and cross the centerline dam on this site.  
Laminated sandy OH material was found to a depth of three feet at the centerline  
of "C" section on the left stream channel.  
Three feet of gravelly materials were found above laminated OH clay at the  
centerline "C" section on the right stream channel.

Centerline of Dam: If the cutoff wall is founded as recommended on seepage submitted with this report most problems relating to near surface permeability and seepage reduction should be resolved.

Principal Spillway: Because of the great similarity of the foundation of the principal spillway to that of the valley floor segment of the centerline of the dam, to the left of the main stream channel, treatment of the principal spillway is the same as recommended for the above segment of the centerline of the dam. Materials used as backfill in the abutment foundation trench should be as identical as possible to those used in backfilling adjacent segments of the cutoff wall trench along the centerline of the dam.

Channel/Stream channel investigation was limited due to excessive stream flow. Gravelly and highly organic materials should be removed from the stream channel.

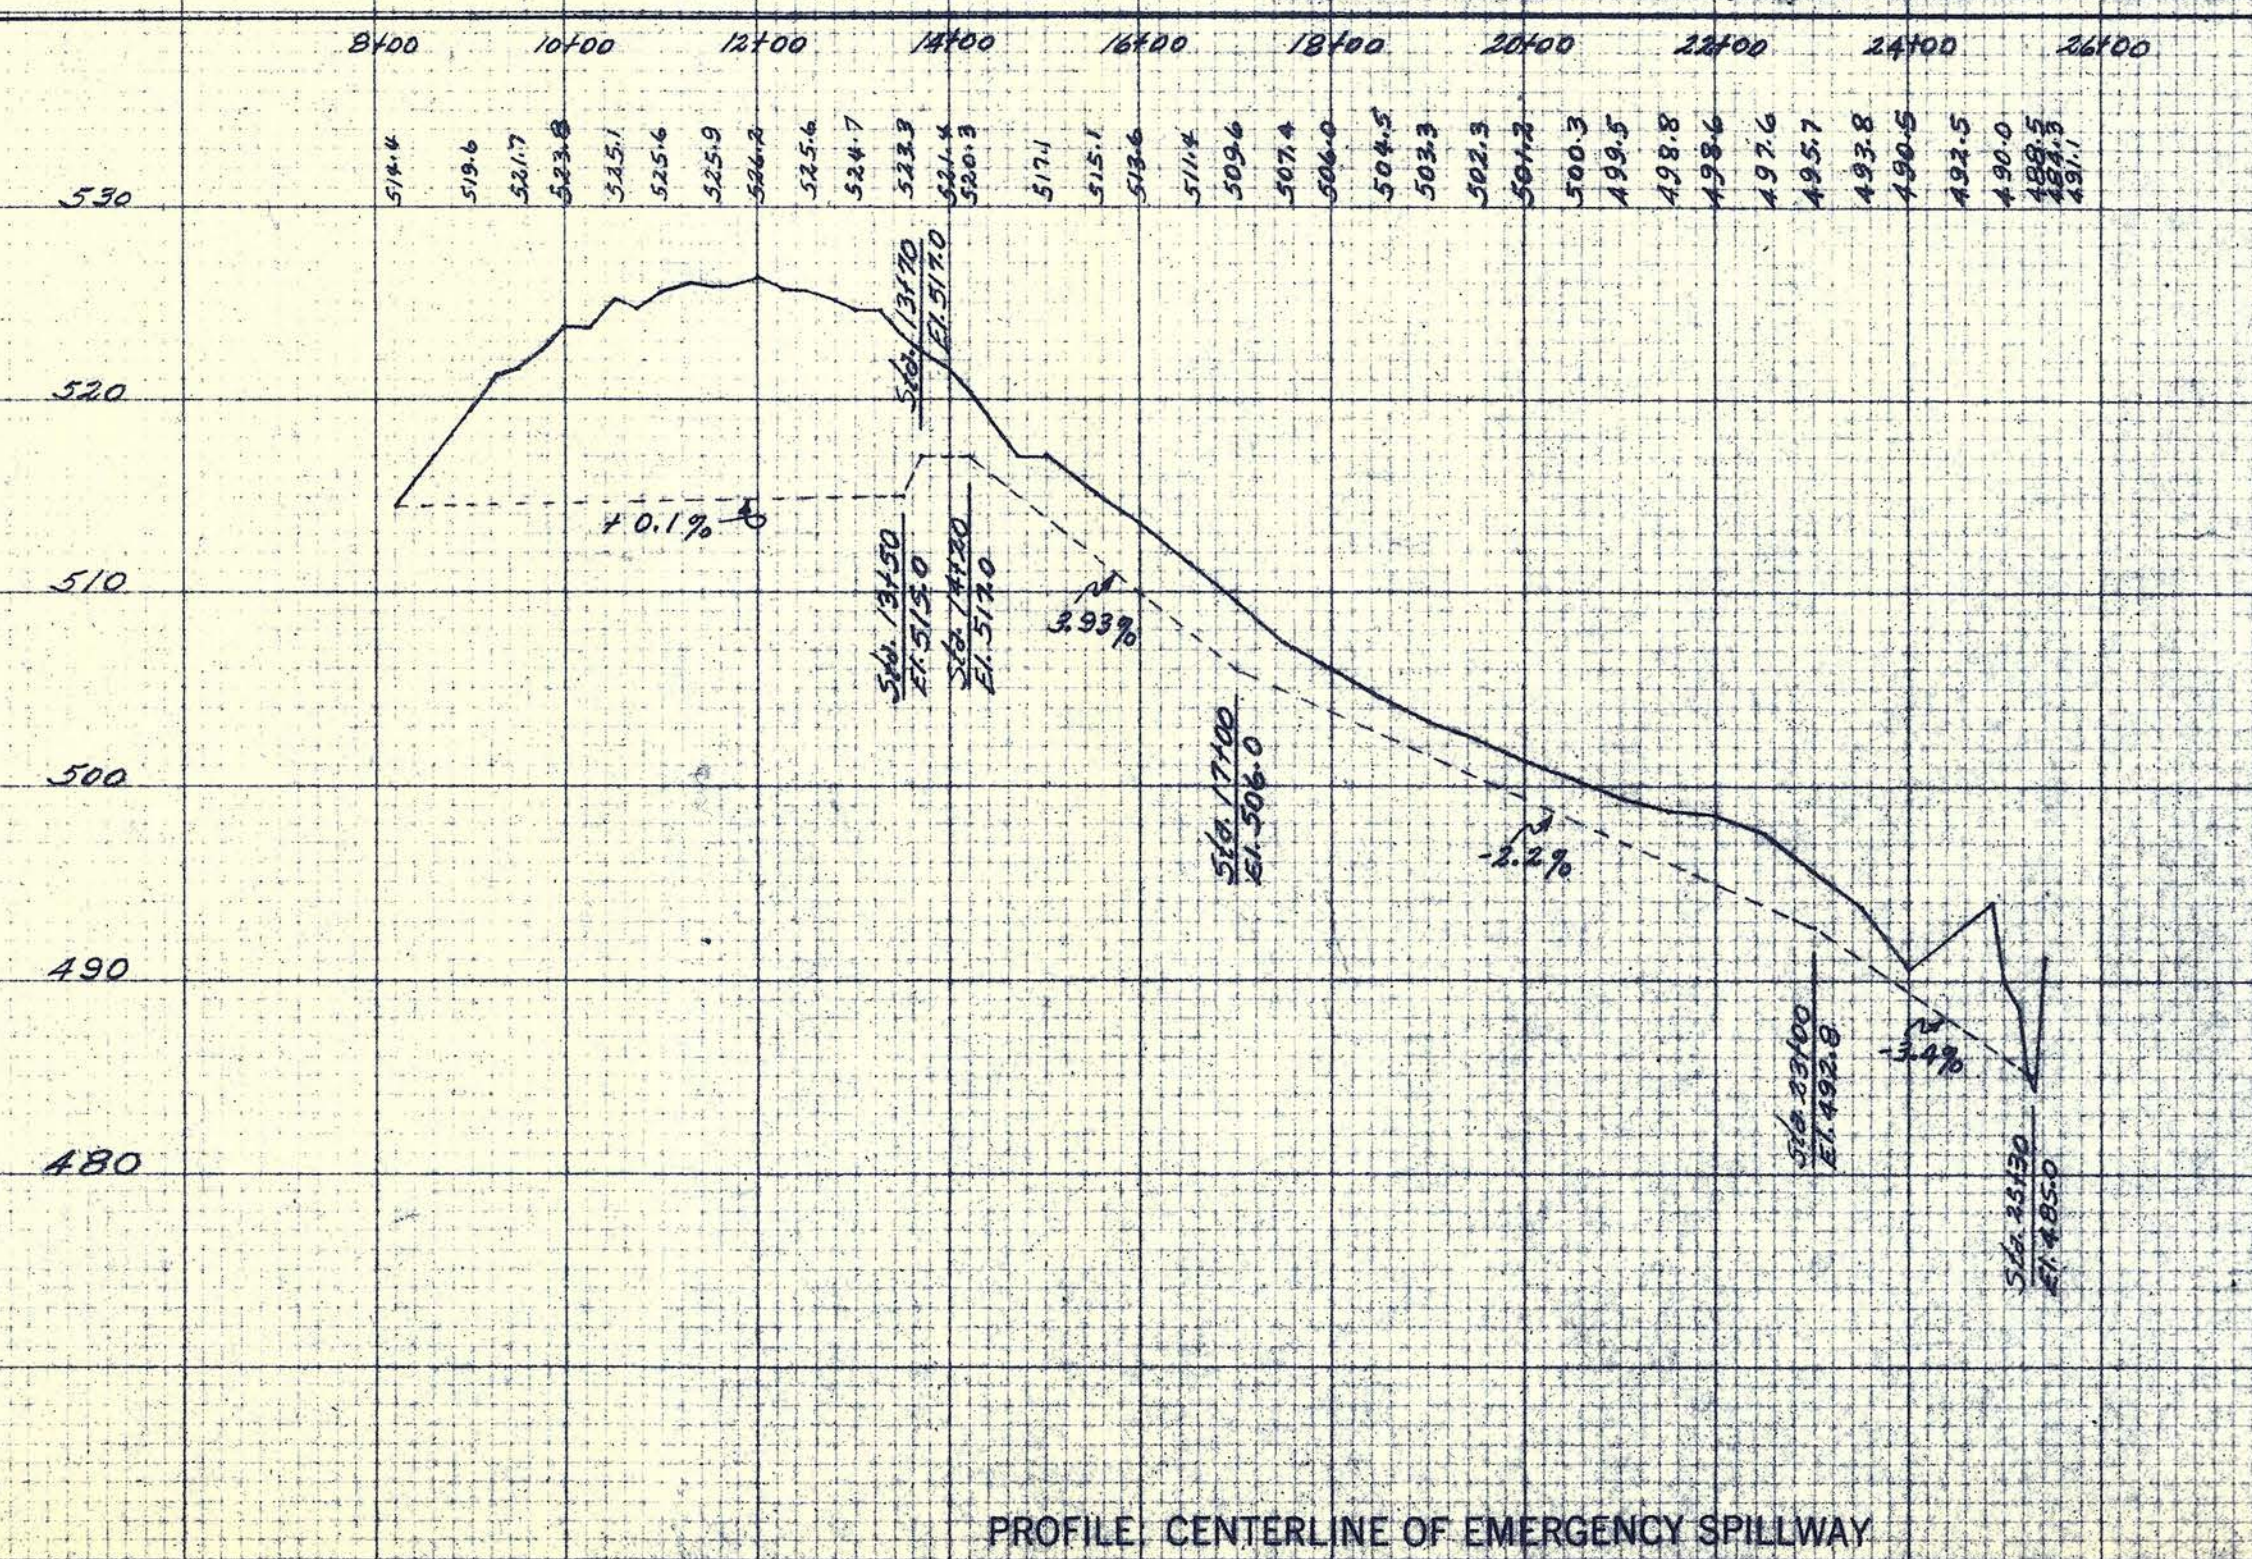
PROFILE, CENTERLINE OF EMERGENCY SPILLWAY

Two soil horizons were found in the forebay section, crest, and upper part of the exit channel of the spillway.

The upper horizon consisted of a sandy CI material.

The lower horizon consisted of interlaminated clay and sand, and was classified as an SC-CI material.

Laminated CI materials similar to those found in zone A of the borrow were found in the lower part of the spillway exit channel.

Secondary Spillway: The second horizon SC-Cl material present in the forebay and crest section of the spillway is highly laminated and contains pockets of less plastic sandy materials.

A more accurate correlation between the laboratory compaction data and the field curve during construction may be obtained by making relative long passes with the scrapers during spillway loading operations.

A vegetative cover should be placed on the spillway soon after construction to reduce the effects of erosion.

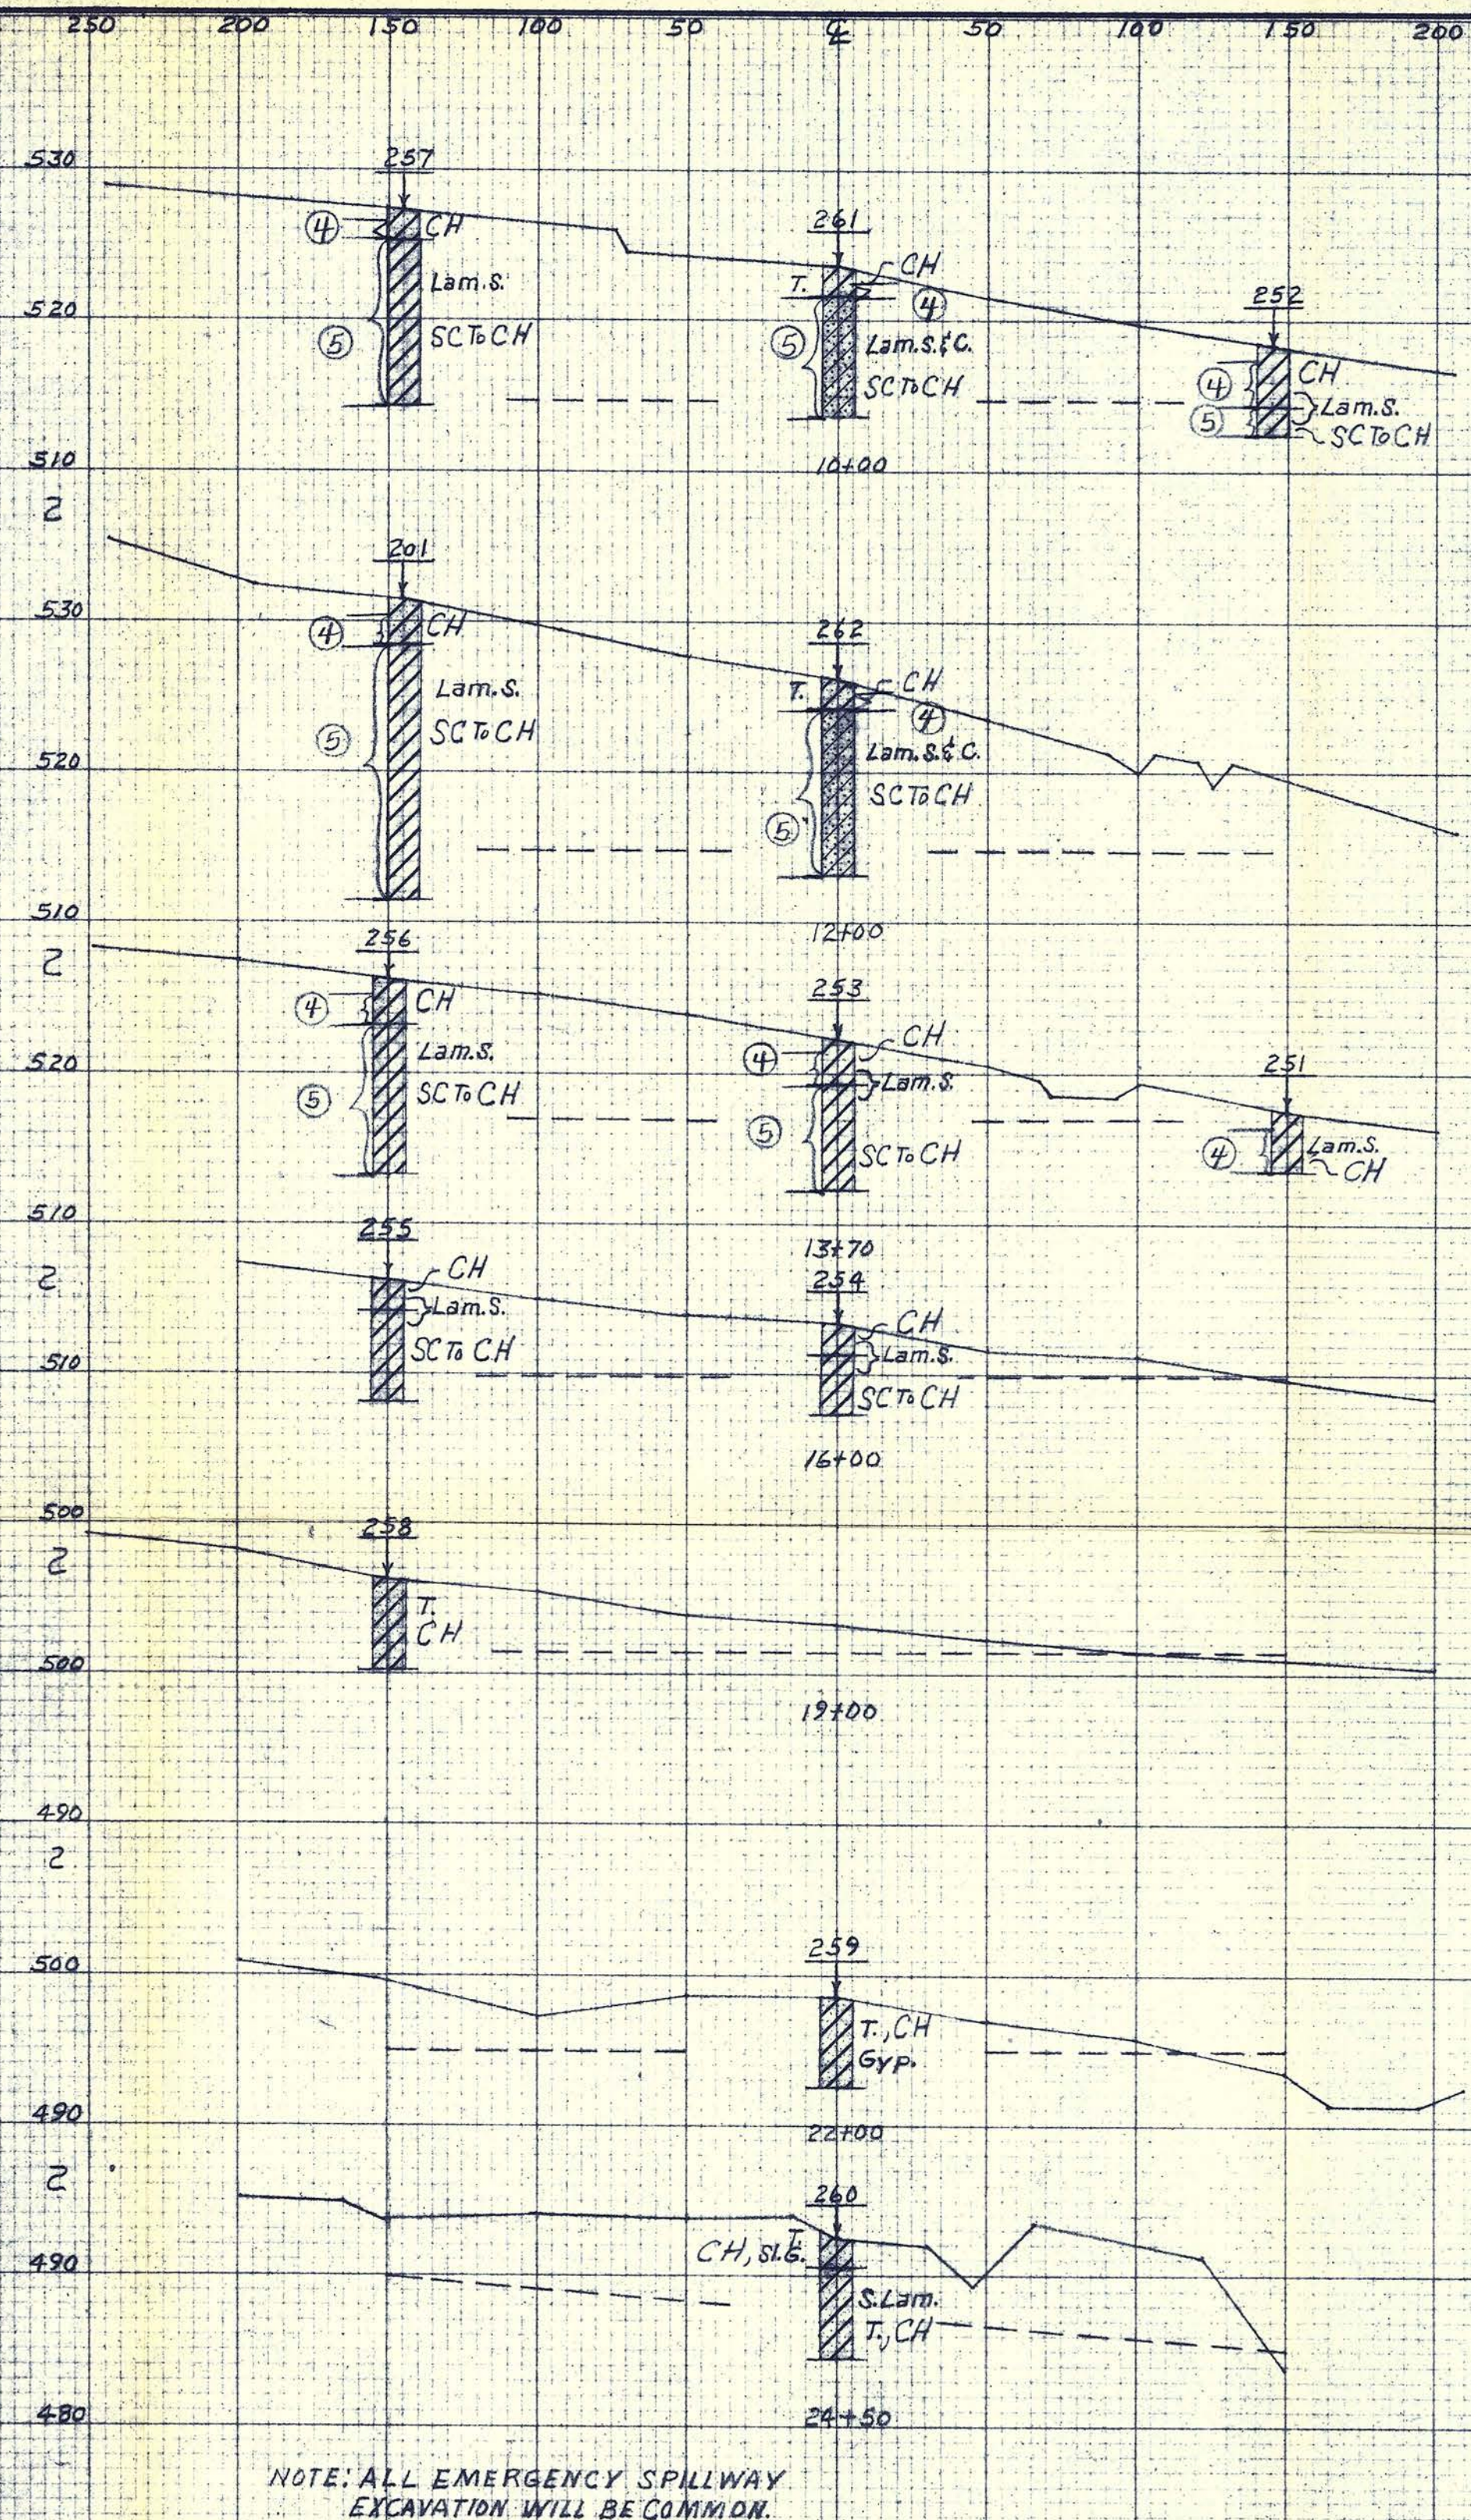
GEOLOGIC CROSS SECTIONS OF EMERGENCY SPILLWAY

NOTE: ALL EMERGENCY SPILLWAY EXCAVATION WILL BE COMMON.
