DETAILED GEOLOGIC INVESTIGATION OF DAM SITES

State Texas County Caldwell Watershed Guadalupe Subwatershed Lower Plum Creek  
Site number 29 Site group I Structure class B Investigated by Henry H. Swann Date 1-19-62  
(signature and title)

INTERPRETATIONS AND CONCLUSIONS

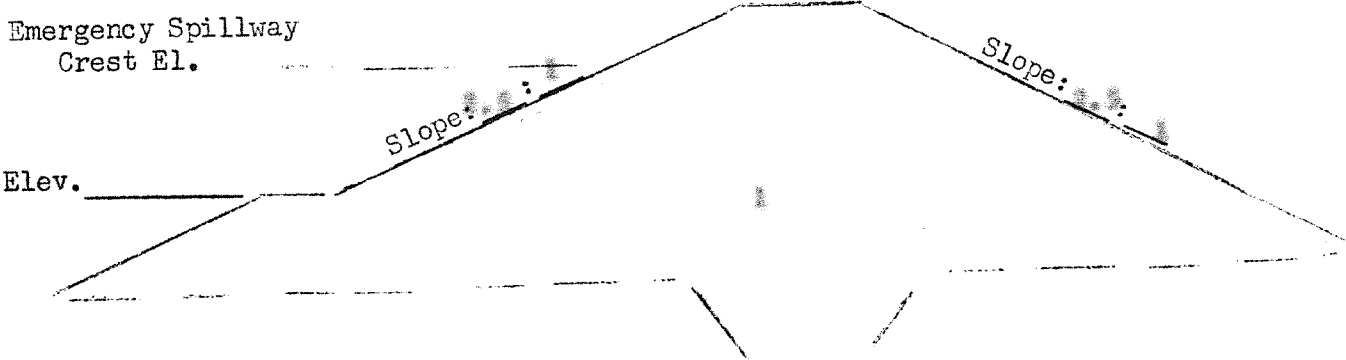
SUGGESTED EMBANKMENT SECTION(S)

Comments: materials to be used in the embankment are as indicated above.
