DETAILED GEOLOGIC INVESTIGATION OF DAM SITES

State Texas County Calderill Watershed Guadalupe Subwatershed Pine Creek  
Site number 21 Site group II Structure class A Investigated by Henry H. Swann Date 7-19-61  
(signature and title)

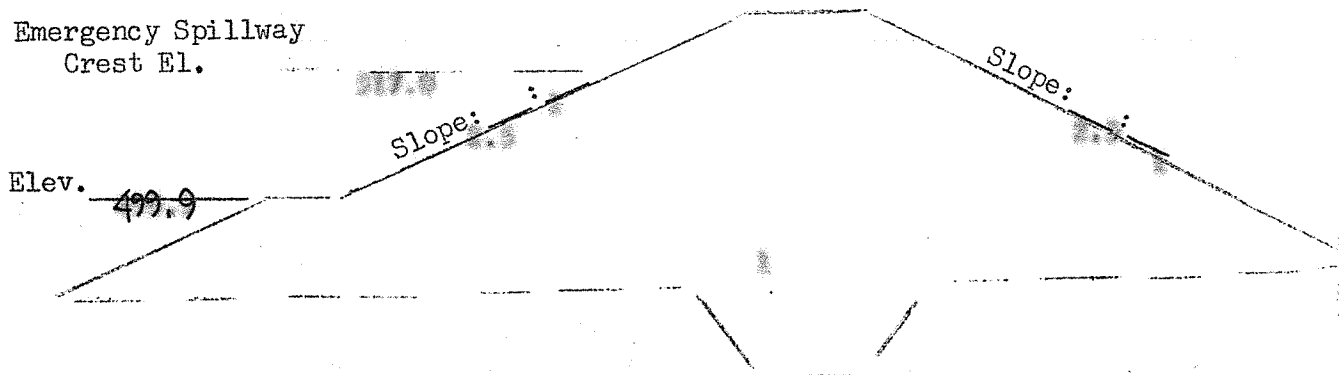
SUGGESTED EMBANKMENT SECTION(S)

Comments: These materials to be placed in subsection on a selective basis at the discretion of the U. S. Government representative. The plastic materials to be placed toward center of subsection and the less plastic materials to be placed in outer portions of subsection, if at all possible.
