## DETAILED GEOLOGIC INVESTIGATION OF DAM SITES

State Texas County Boys ; 1/2, 1/2, Sec.       , T        R        ; Watershed Guadalupe  
 Subwatershed Blue Creek Fund class 3000 Site number 17 Site group II Structure class A  
 (FP-2, WP-1, etc.)  
 Investigated by Dale L. Bidwell (signature and title) Geol. Equipment used Rolling Hills (Type, size, make, model, etc.) Date 11-9-61

State Texas County Hays Watershed Guadalupe Subwatershed Plus Creek  
Site number 12 Site group II Structure class A Investigated by Henry H. Swope Date: 11-8-61  
(signature and title)

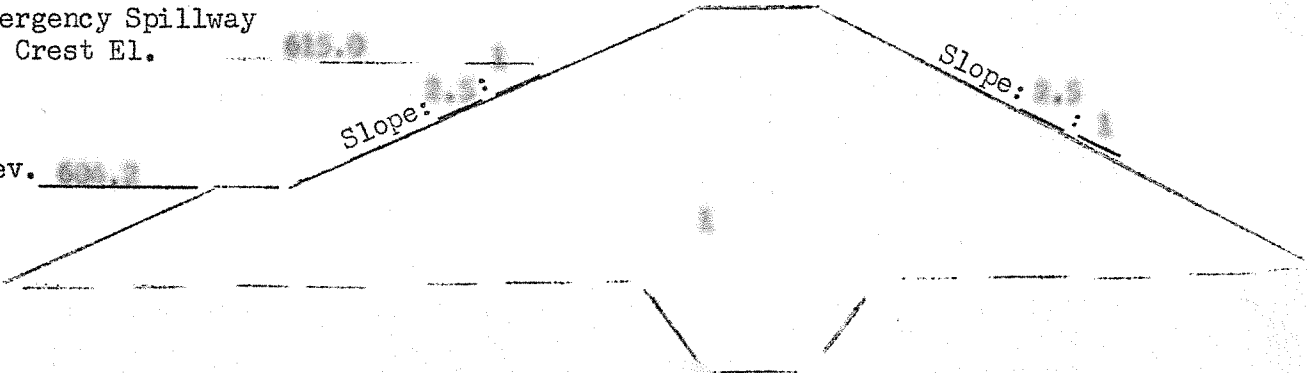
SUGGESTED EMBANKMENT SECTION(S)

Comments: All materials may be used in zone 1 on a selective basis.

Borrow: Gravelly CH and CH-GC materials found in the borrow may best be used in the outer sections of the dam.

Other CH materials in the borrow may be used anywhere in the dam.

Emergency Spillway: From the information now available from the spillway, before test pits have been put down, CH materials may be used anywhere in the dam and GC materials may best be used in the downstream section of the dam.
