SUPPLEMENTAL SPILLWAY REPORT

DETAILED GEOLOGIC INVESTIGATION OF DAM SITES

State Texas County Hays ; 1/4, 1/4, Sec. _____, T _____ R _____ ; Watershed Guadalupe River

Subwatershed Plum Creek Fund class (WP-2)23 Site number 12 Site group II Structure class A
(FP-2, WP-1, etc.)

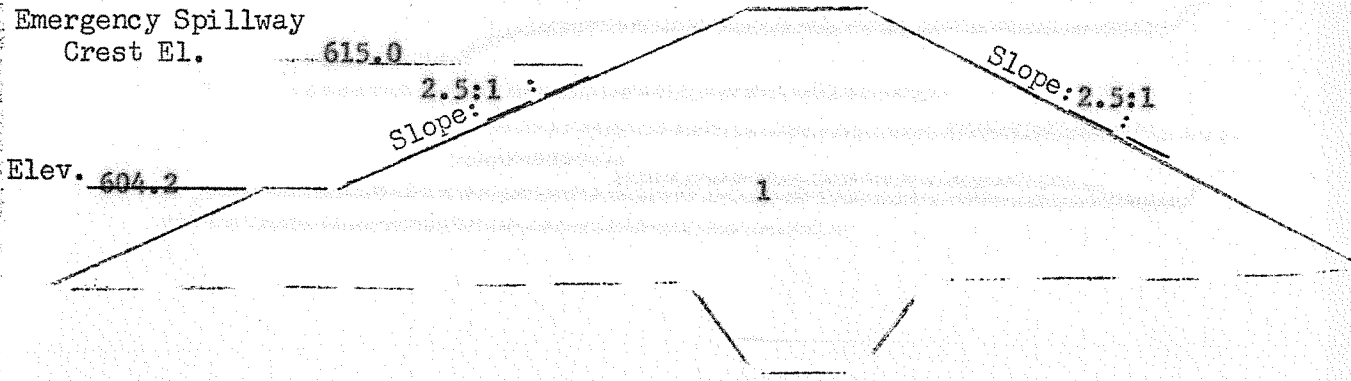
SUGGESTED EMBANKMENT SECTION(S)

Comp. No.	Material Source	Hole Nos.	Field Class.	Depth From	Depth To	Emb. Sec.	Quan. Avail. (Est.) Cu. Yds.
4	Emer. Spillway	252,201,203 253,255,206	CH	0.0	3.0	1	25,000
6	" "	252,201,203 253,206	CH	7.0	to grade	1	10,000
7A & B	" "	2201,2202,2203 2204,2205	GC	3.0	7.0	1	25,000
<p>Estimated quantities of available materials re-evaluated for the Revised Emergency Spillway. All other data on Sheet 2 of 3 of the Original Trial Forms remains unchanged. Composite #7A and B will be used in the place of Composite #5.</p>

GC materials may best be used in the downstream section of the dam.
