### 2013 Halloween Flood Cleanup & Repair

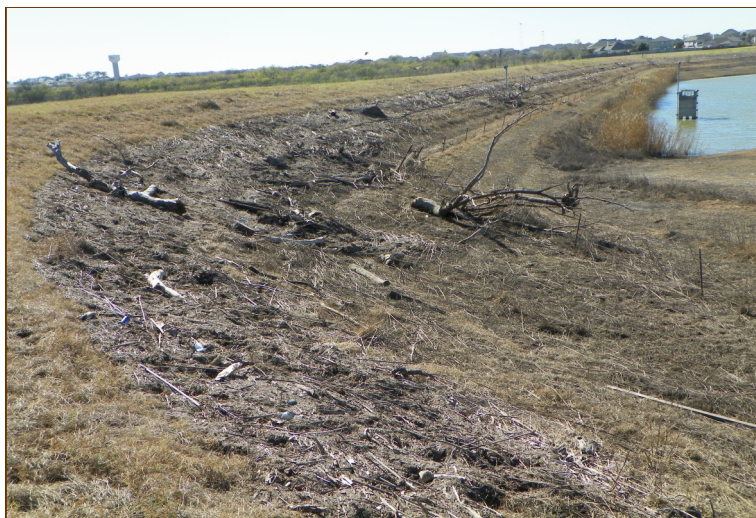
Site # 2 scattered debris along the dam right after flooding

spillway had also been eroded and was repaired. The purpose of an auxiliary spillway is to convey excess flood waters around the dam when floodwaters rise past the spillway crest. Sites 12,14, and 16 had waters flow around their auxiliary spillways, while many of the other dams had water levels nearly reach their spillway crests. Last, considerable amounts of debris were either mulched or removed for sites 1,2,5,6,8,12,14,16,21, and 27. The total cost for cleanup and repairs was \$135,738.

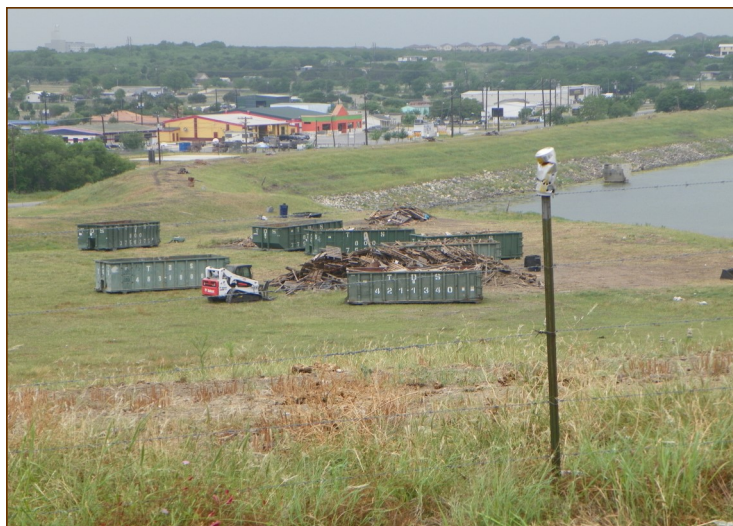
Site # 6 debris cleanup in progress

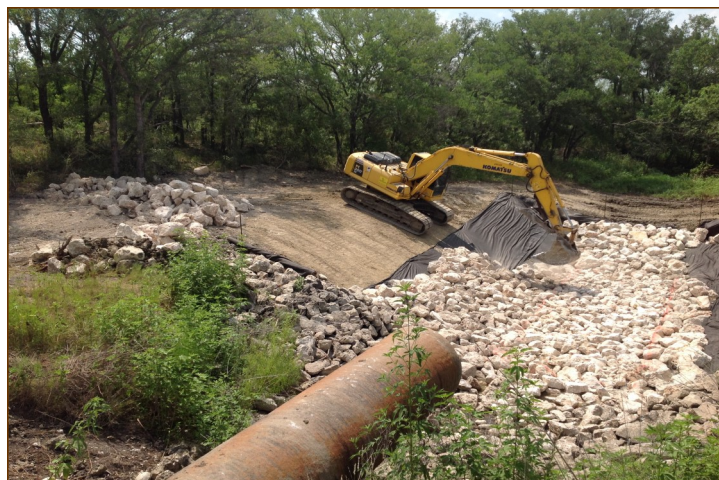
Site # 14 repair of the plunge basin

financial assistance through FEMA for the necessary clean up and repairs. Three dams, sites 11,12 and 14, had repairs completed to their plunge basins. The function of a plunge basin is to catch and dissipate the water flow being released from the principal spillway, minimizing erosion as water moves downstream. The repairs to the plunge basins entailed sculpting the basins as originally designed, lining the bottoms with special material and adding and replacing the rock that had been displaced. In addition, site 12 had repairs to areas along the dam, where wave action had caused erosional damage. A portion of Site 12's auxiliary
