Site 6 Rehabilitation Update

Repairs to Several of PCCD's Dams Complete with More to Come

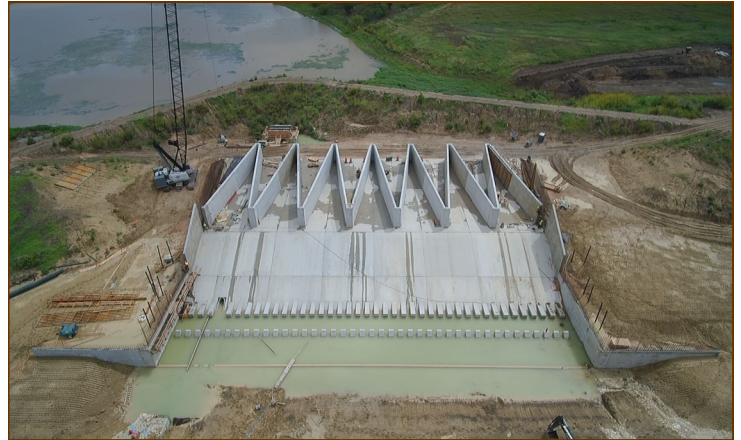
Aerial view of the site 6 Dam rehabilitation project showing the labyrinth weir spillway

completed in a timely manner. Once complete, the dam will be able to handle a probable maximum flood (PMF) storm event. A PMF, in short, is the largest storm that could conceivably occur at a particular location. A PMF's determination is based on the historical climate data for the area, along with the hydrological characteristics of a dam's watershed (8.13 square miles for Site 6). The total precipitation involved in a PMF is called the Probable Maximum Precipitation (PMP). Site 6's PMP is 13.3 inches occurring over a 6 hour time period.

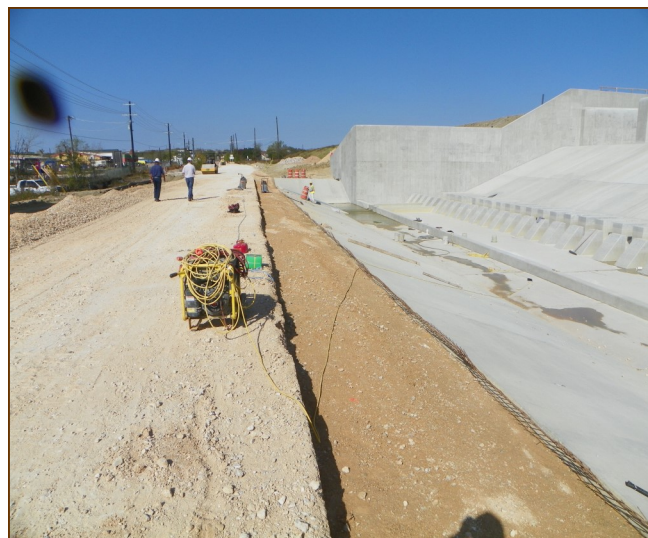
Below site 6 and the construction of Goforth road

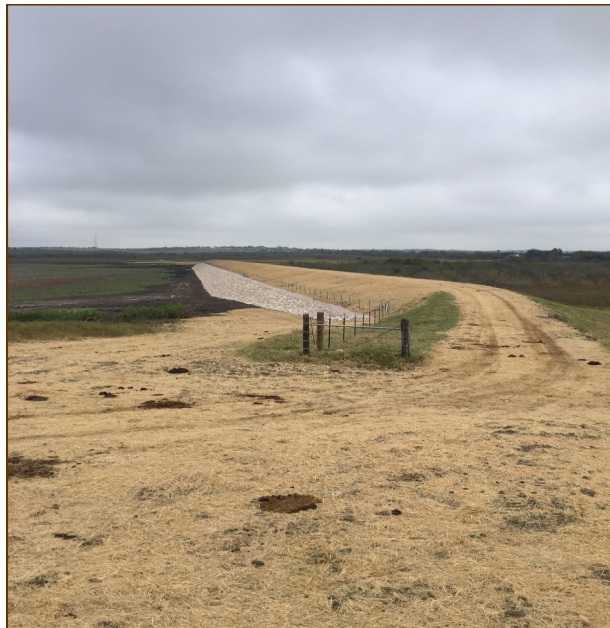
Site 12 EWP completed construction looking at the upstream embankment with installed riprap

| Dam Number | Specific damage | Estimated Cost of Repair |
|---|---|---|
| 12 | Erosion on the upstream embankment of dam | \$ 668, 618 |

The District has just finished up repairs for several of its dams that were damaged due to the 2015 flood event (May 2015). Following the flood event, PCCD applied for and was granted funding through the Emergency Watershed Protection (EWP) program for several of its dams. The EWP program, administered by the Natural Resources Conservation Service (NRCS), responds to natural disasters, such as floods, by providing financial and technical assistance. NRCS pays for 75% of the cost while the remaining 25% is paid for by a local sponsor. Below is a table listing the PCCD dams that have been repaired, their specific damage, and the associated costs of the repairs.

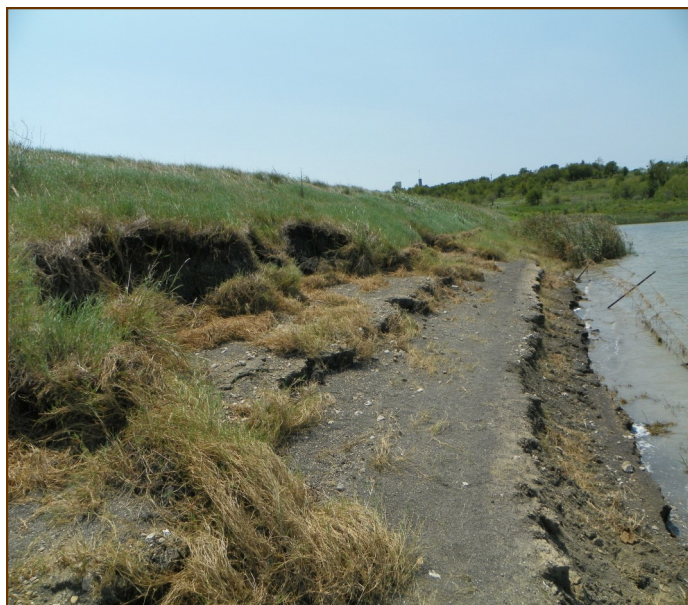
On August 26th, 2017, Hurricane Harvey hit and caused damage to several of our dams (sites 10, 11, &

Significant erosional damage along the face of the upstream embankment for Site 10 following the 2017 flooding.

28). Following a Damage Survey Report completed by the NRCS, PCCD has again applied for EWP assistance to defray the cost of needed repairs. Over the last several years, as in 2013, 2015 and 2017, the District experienced flooding that damaged our dams. Fortunately, financial aid for repairs was available through the federal government. Whether this trend of frequent flooding will continue is not known but, if it does, it is currently uncertain whether the financial assistance received in the past will continue to be available.
