Geologic Investigation Report

Plum Creek Watershed FRS No. 2 Rehabilitation Design
Hays County, Texas

Work Order number: 12FPC219F0063
Contract number: IDIQ-AECOM-2018-79017
AECOM Project number: 60615067

June 2021

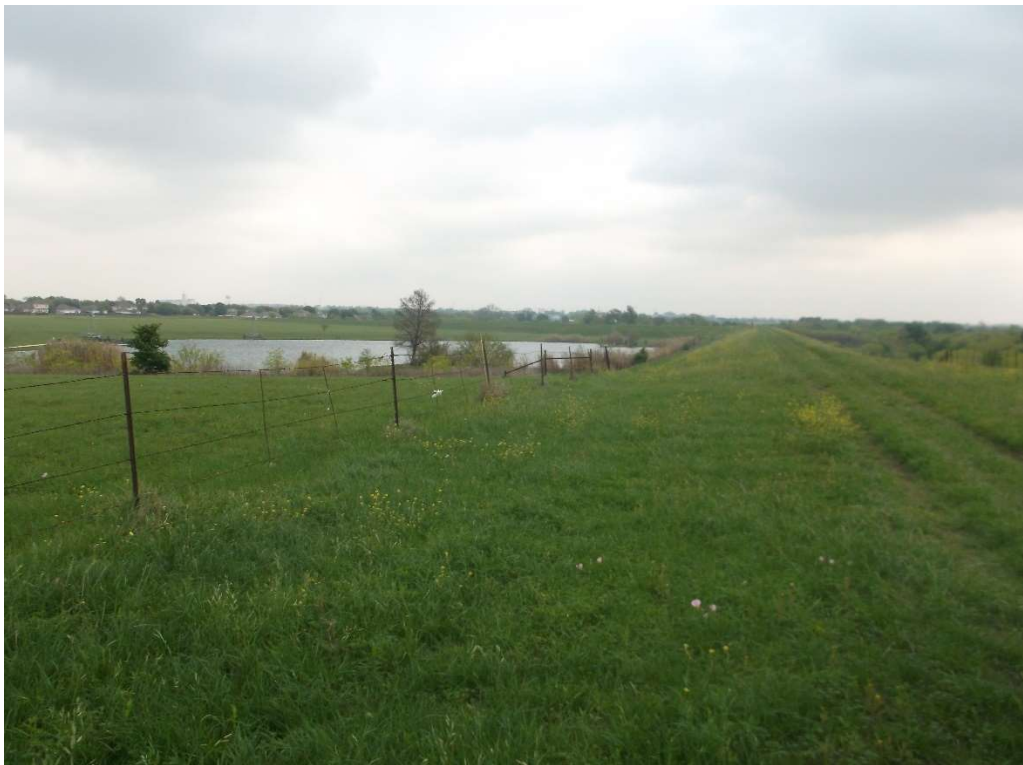
Client Name: Texas State Soil and Water Conservation Board		Site Location: Plum FRS No. 2 - East of Kyle, TX	Project No. 60615067
Photo No. 1	Date: 03/26/2020

Description: Photo facing northwest direction shows the existing dam embankment crest and the reservoir. Uniform vegetative covering is observed throughout the embankment. Rutting marks can be seen on the crest of the dam.

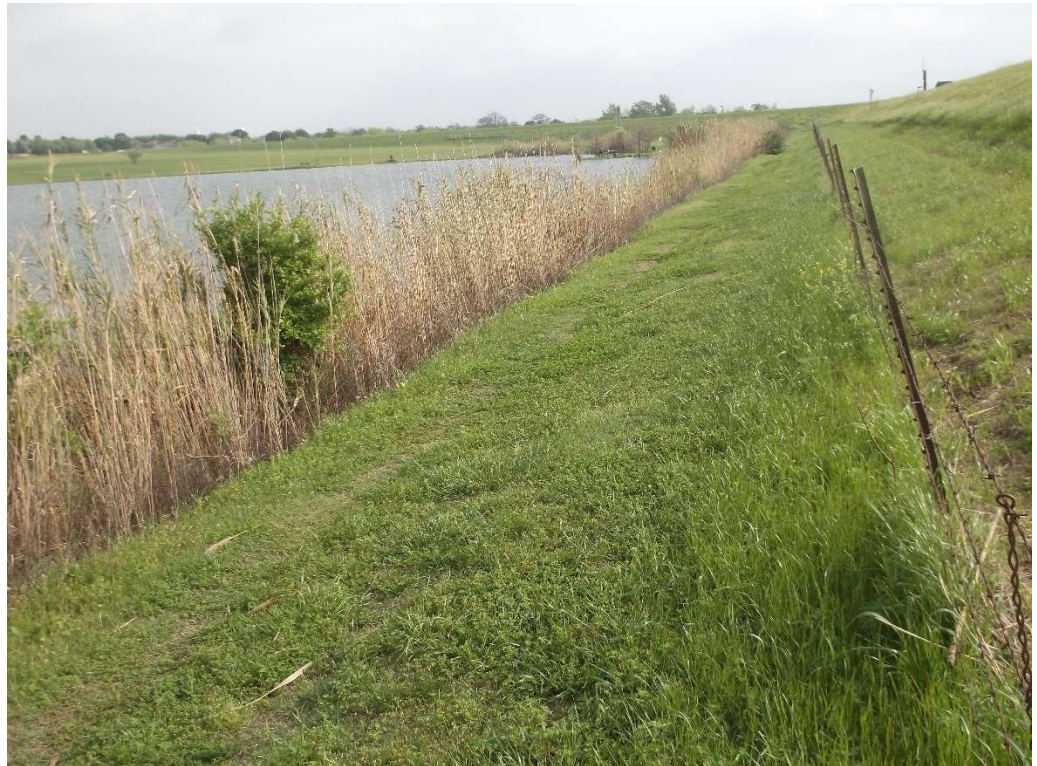
Photo facing northwest direction provides additional view of the upstream embankment slope and impoundment. Barbed wire fencing can be seen in the foreground along the upstream slope. Tall vegetation is shown along the upstream toe.

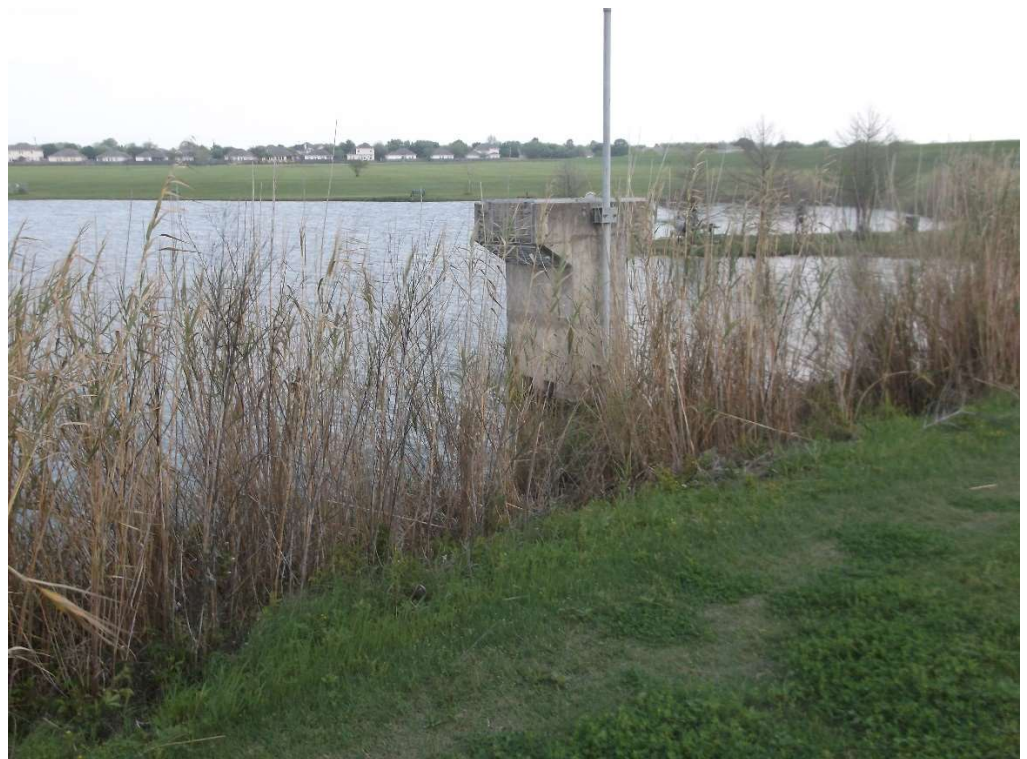
**Photo No.**
4**Date:**
03/26/2020**Description:**

Photo facing northwest shows the intake tower and stage recorder. Tall vegetation can be seen along the upstream toe of the dam near the reservoir.

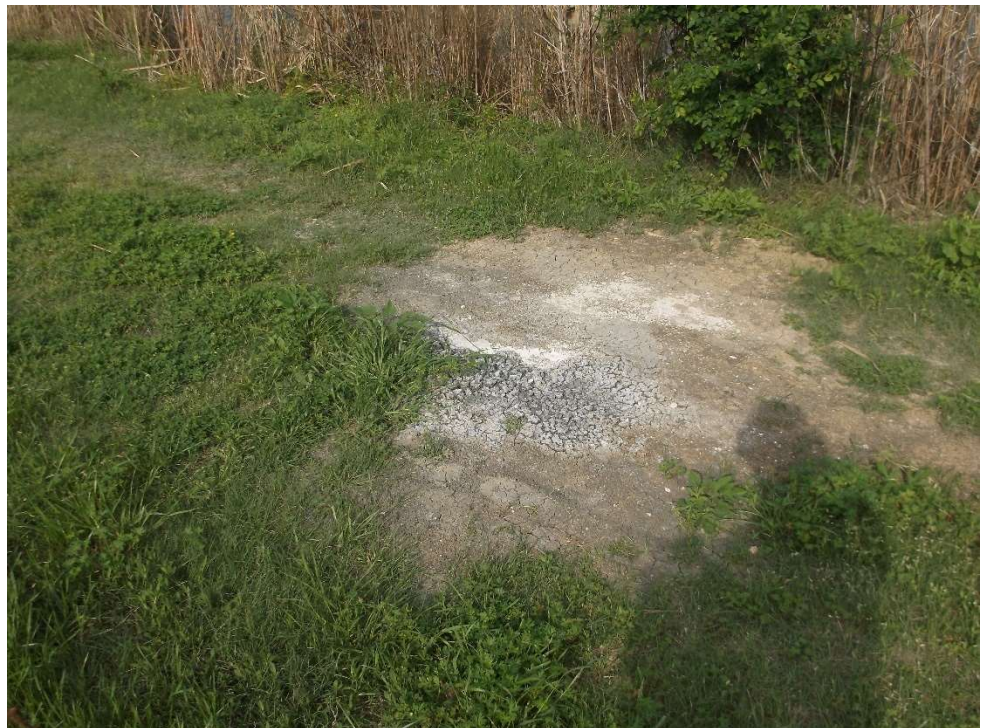
**Photo No.**
6**Date:**
03/26/2020**Description:**

A focused view of possible rutting and erosion damage observed near the upstream toe of the dam. Photo facing southwest direction.

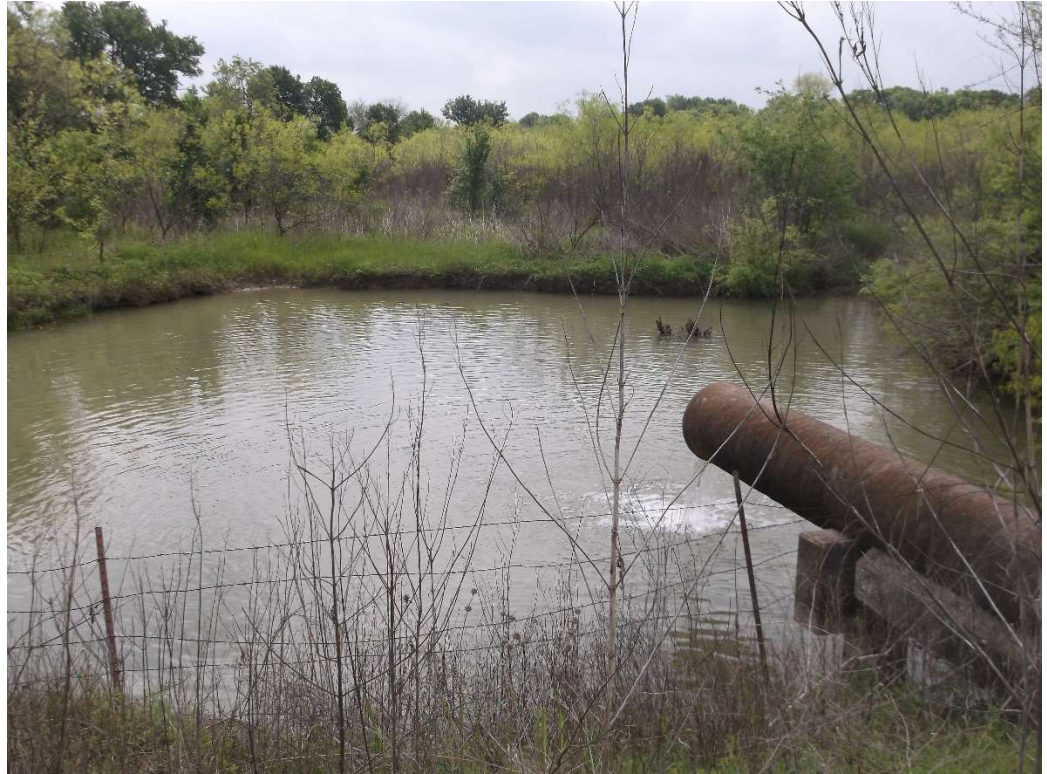
Photo facing southeast direction shows the existing 24-inch I.D. principal spillway conduit, pipe cradle, and stilling basin. Well established vegetation can be seen on the background along the edges of the stilling basin.

Some erosion was observed under the cradle of the principal spillway conduit. This area of erosion was observed in previous inspections and has been monitored by NRCS since at least 2006. High vegetative covering did not allow for closer inspection of the erosion area, but no evidence of structural distress was noted.

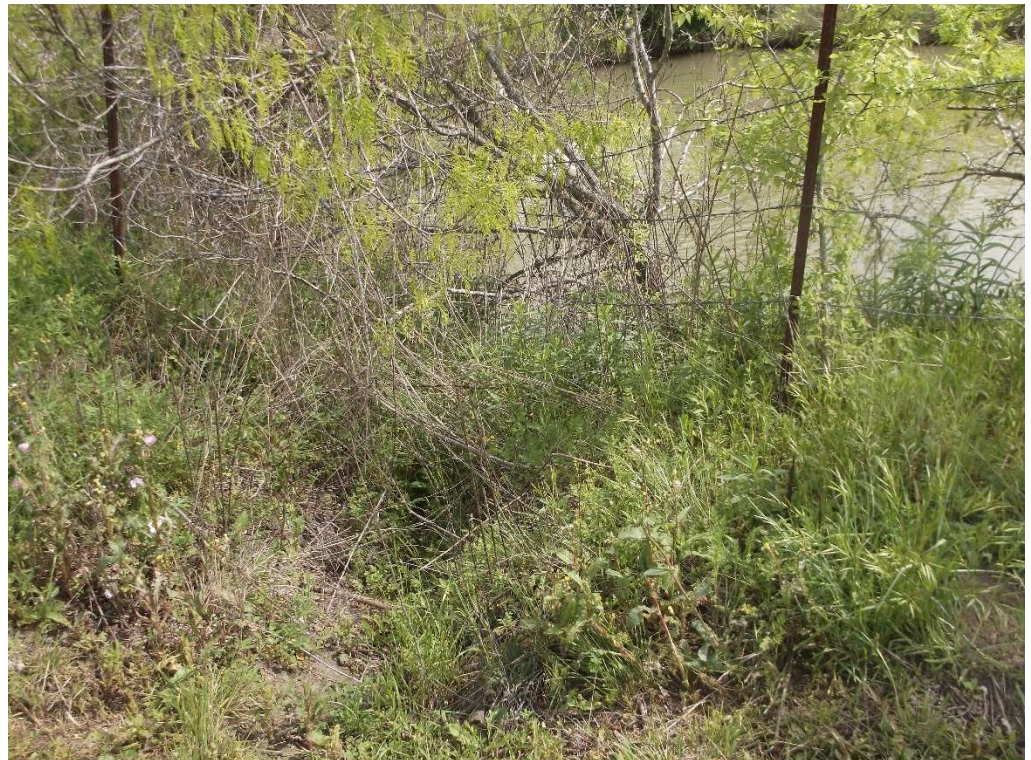
A focused view of suspected animal burrow and/or area of erosion observed near the fencing surrounding the principal spillway stilling basin.

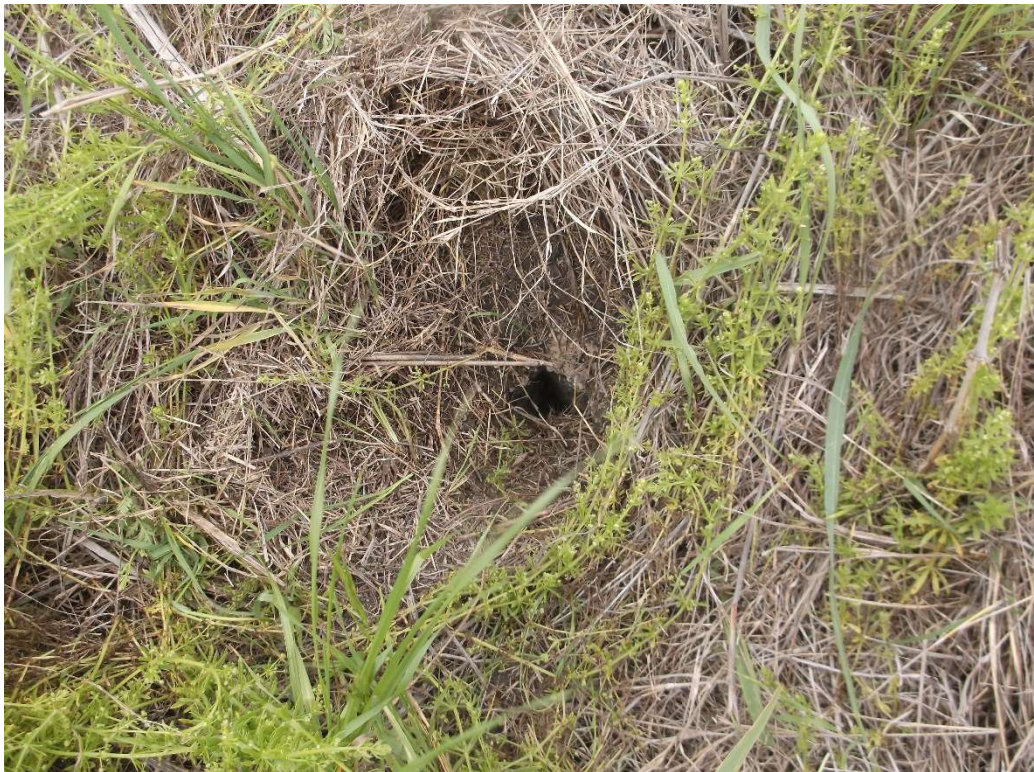
Client Name: Texas State Soil and Water Conservation Board		Site Location: Plum FRS No. 2 - East of Kyle, TX	Project No. 60615067
Photo No. 13	Date: 03/26/2020

Description: Additional view of animal burrow observed during field inspection.

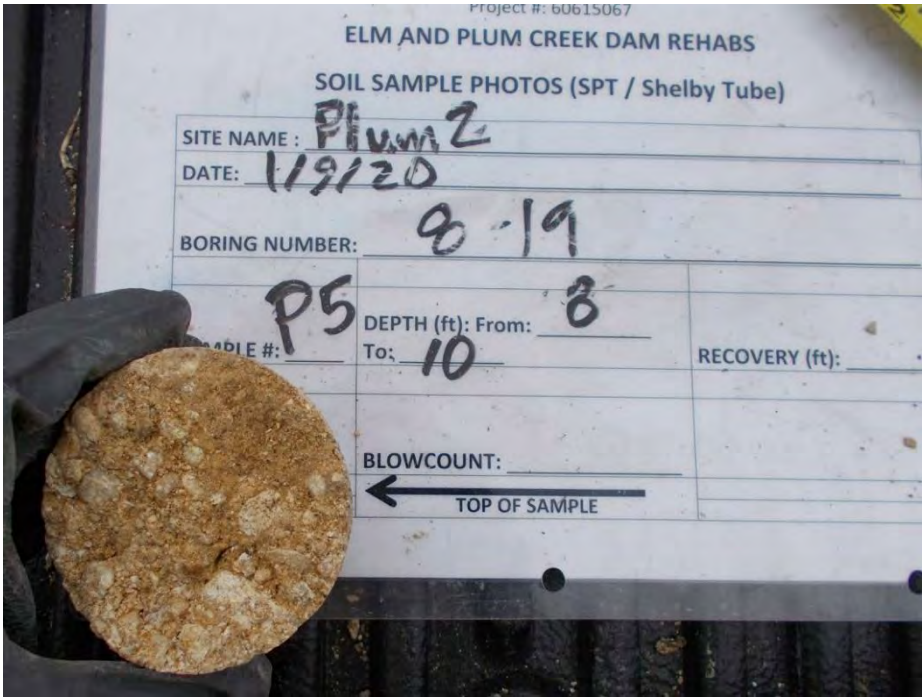
Photo No. 6	Date: 12/9/19

Description: Boring 8-19. P-5. Depths ~ 8-10 ft

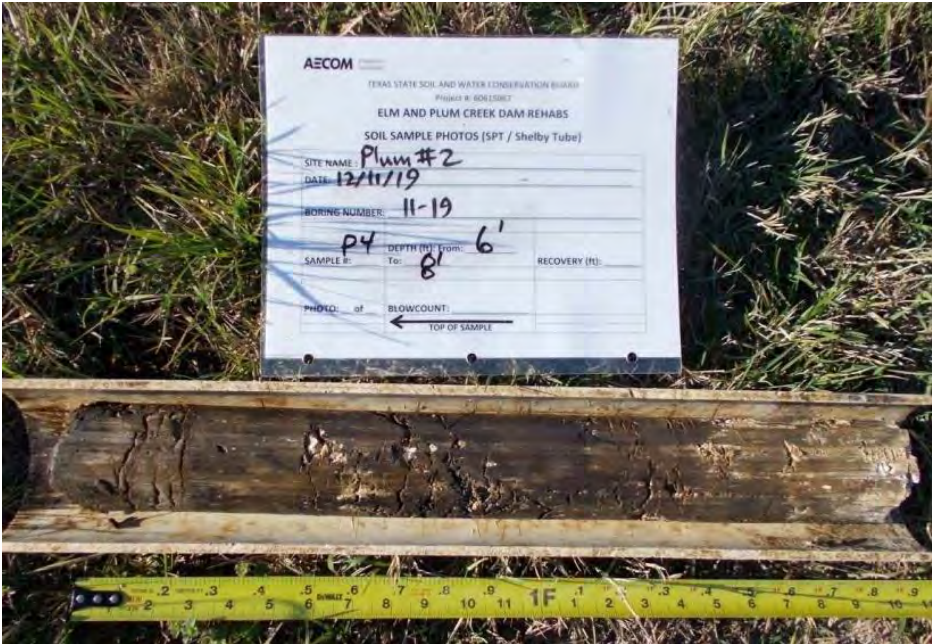
Client Name: TSSWCB		Site Location: Plum 2: Kyle, TX	Project No. 60615067
Photo No. 5	Date: 12/9/19

Description: Boring 11-19. SS-5. Depths ~ 8.5-10 ft.

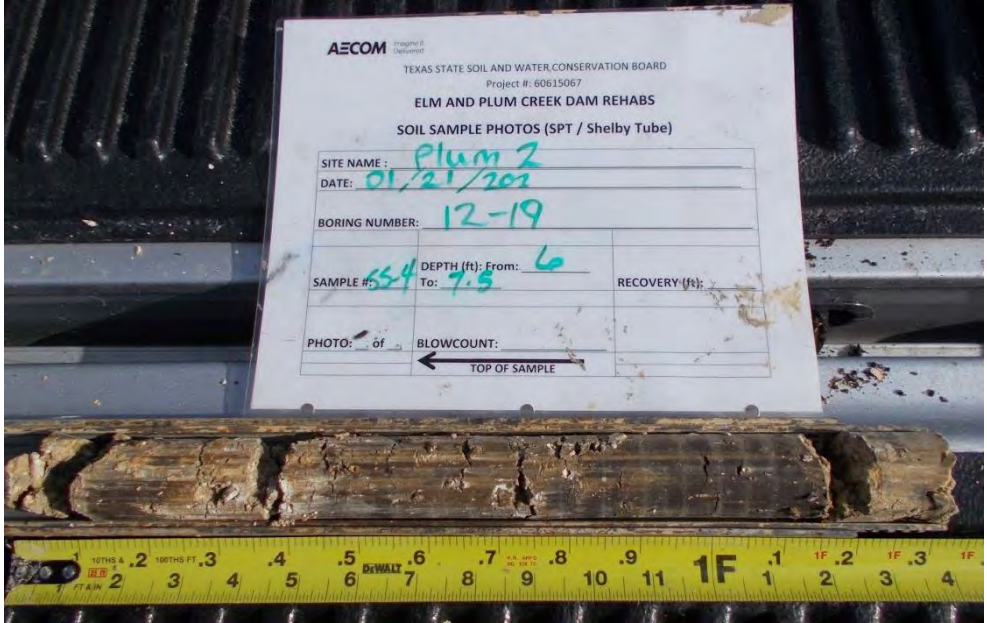
Photo No. 4	Date: 12/9/19

Description: Boring 12-19. SS-4. Depths ~ 6-7.5 ft

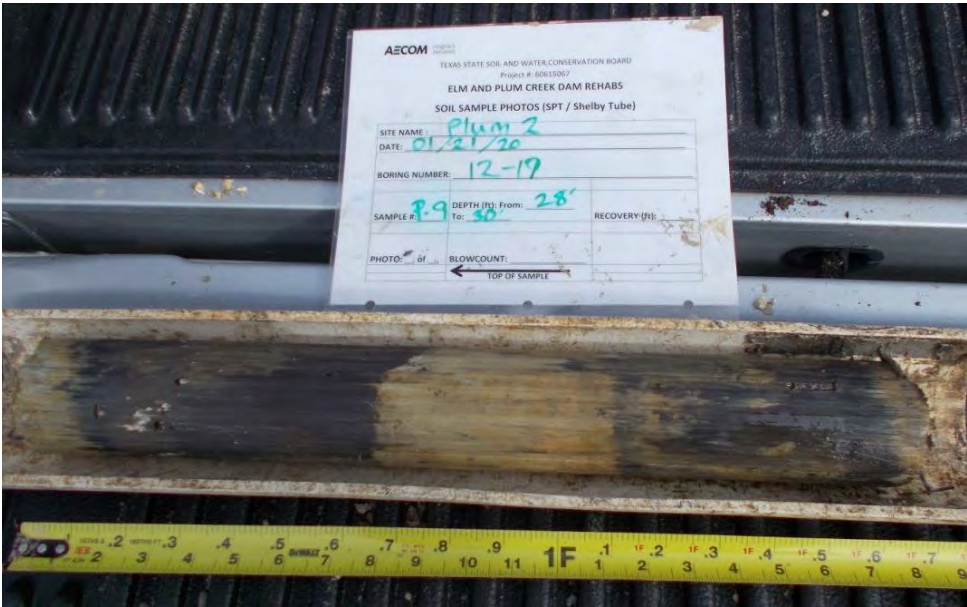
Client Name: TSSWCB		Site Location: Plum 2: Kyle, TX	Project No. 60615067
Photo No. 9	Date: 12/9/19

Description: Boring 12-19. P-9. Depths ~ 28-30 ft

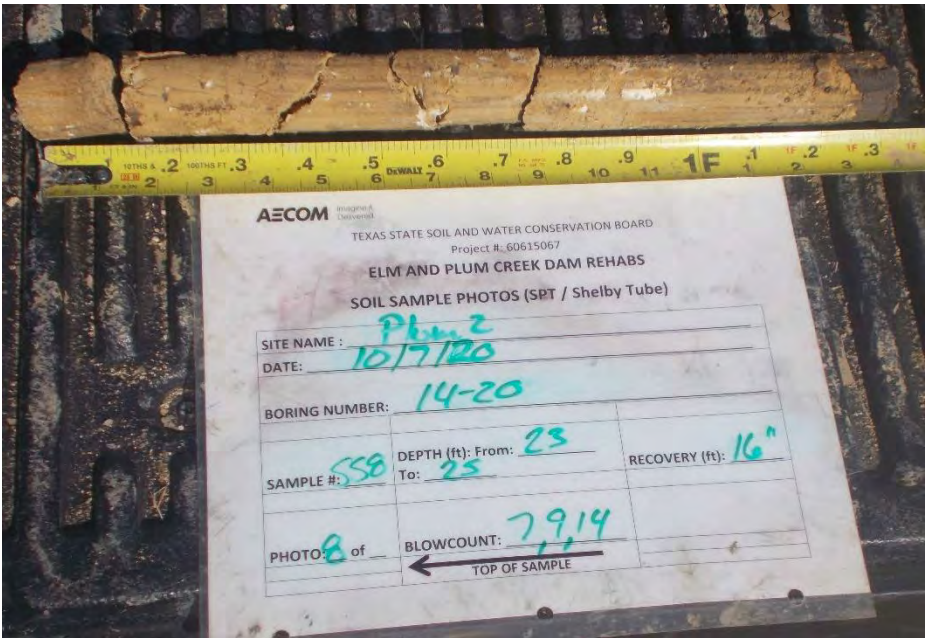
Photo No. 8	Date: 10/1/20

Description: Boring 14-20 Sample: SS-8 Depths: 23-25 ft

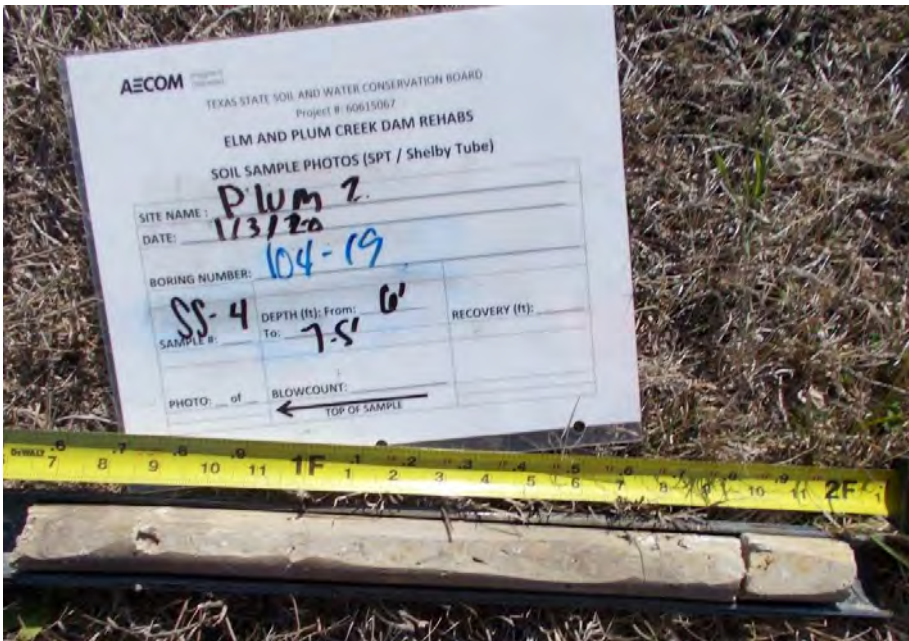
Photo No. 4	Date: 12/9/19

Description: Boring 104-19. SS-5. Depths ~ 6-7.5 ft

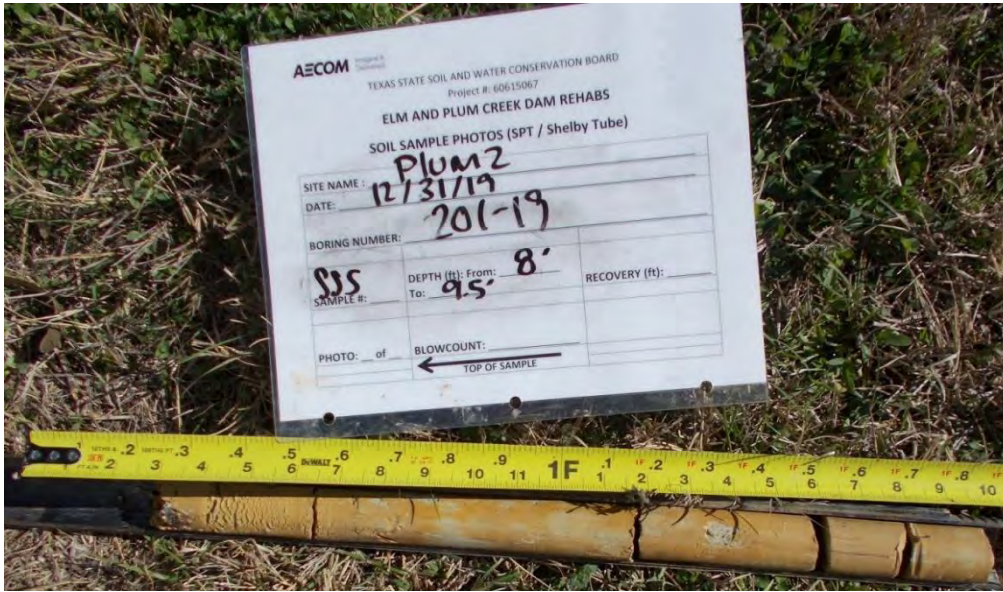
Client Name: TSSWCB		Site Location: Plum 2: Kyle, TX	Project No. 60615067
Photo No. 5	Date: 12/9/19

Description: Boring 201-19. SS-5. Depths ~ 8-9.5 ft

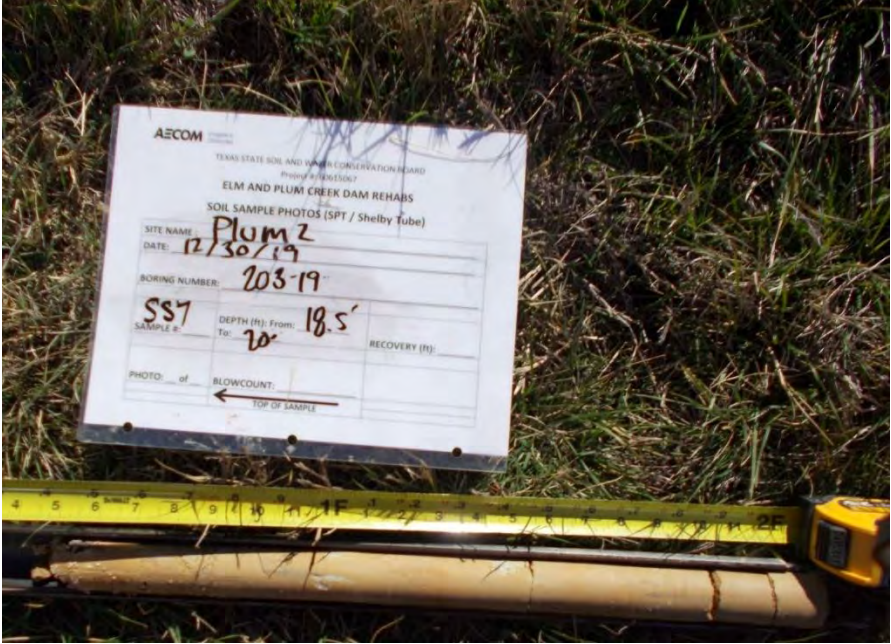
Client Name: TSSWCB		Site Location: Plum 2: Kyle, TX	Project No. 60615067
Photo No. 7	Date: 12/9/19

Description: Boring 203-19. SS-7. Depths ~ 18.5-20 ft

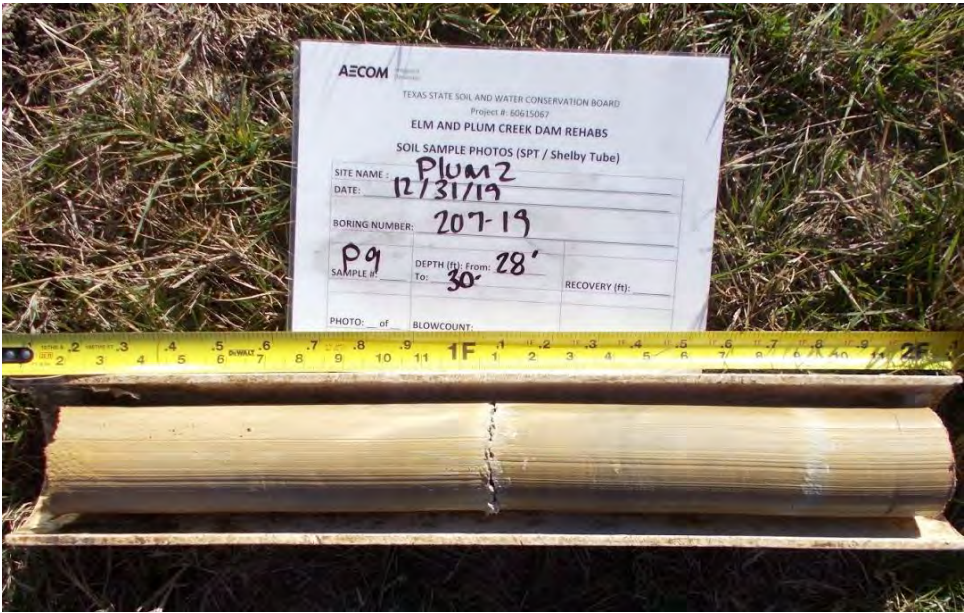
Client Name: TSSWCB		Site Location: Plum 2: Kyle, TX	Project No. 60615067
Photo No. 9	Date: 12/9/19

Description: Boring 207-19. P-9. Depths ~ 28-30 ft

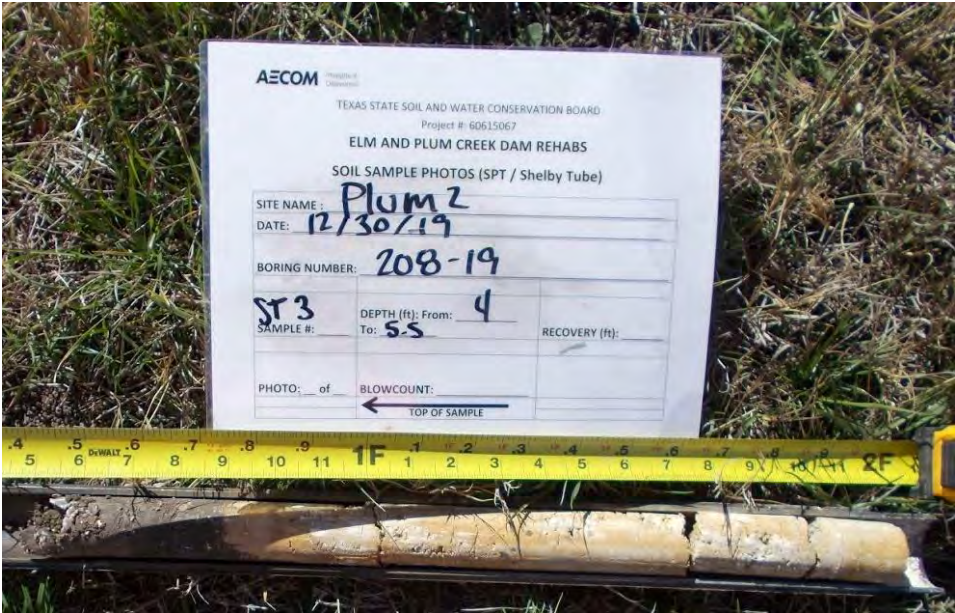
Client Name: TSSWCB		Site Location: Plum 2: Kyle, TX	Project No. 60615067
Photo No. 3	Date: 12/9/19

Description: Boring 208-19. SS-3. Depths ~ 4-5.5 ft

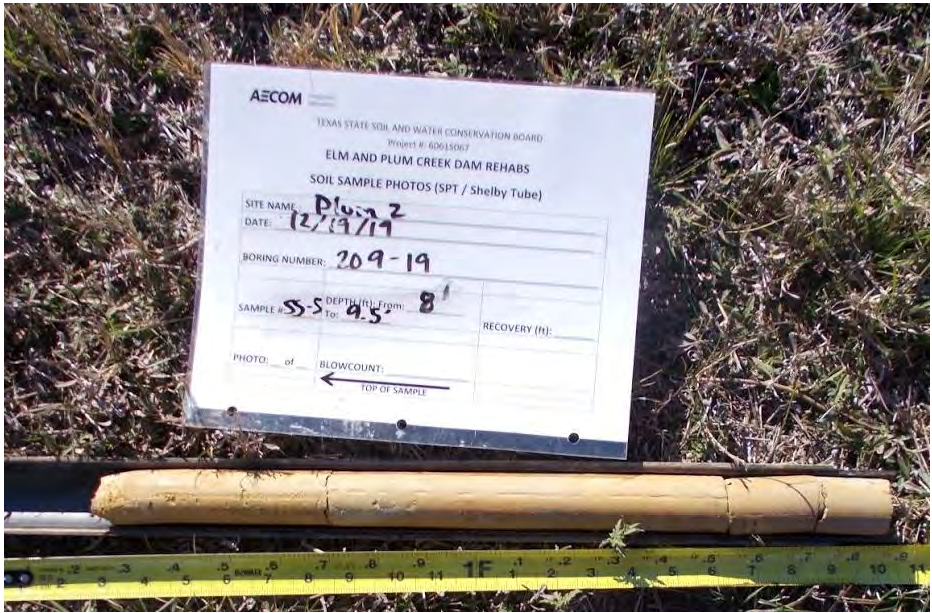
Client Name: TSSWCB		Site Location: Plum 2: Kyle, TX	Project No. 60615067
Photo No. 5	Date: 12/9/19

Description: Boring 209-19. SS-5. Depths ~ 8-9.5 ft

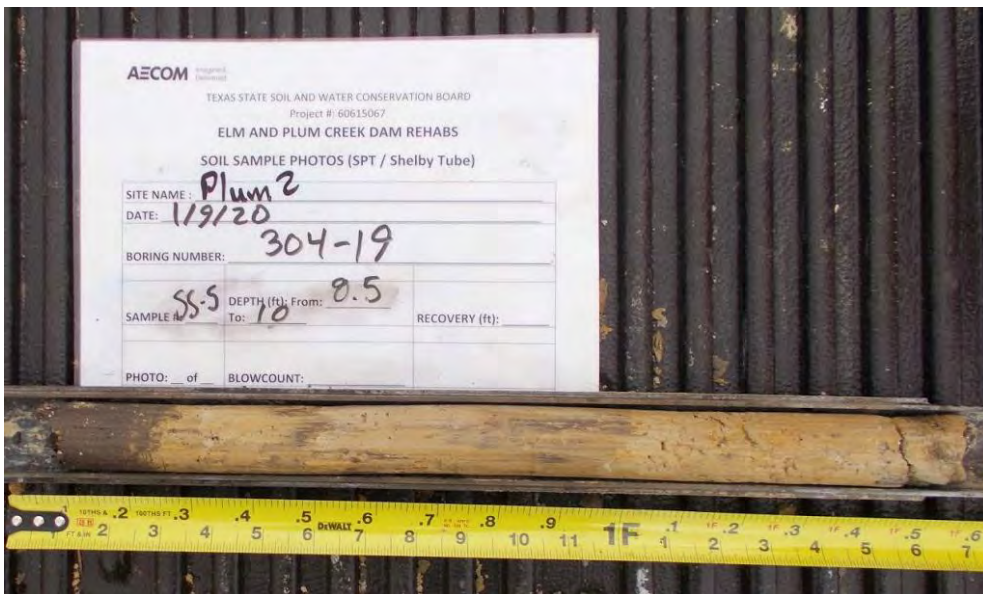
Photo No. 6	Date: 12/9/19

Description: Boring 304-19. SS-5. Depths ~ 8.5-10 ft

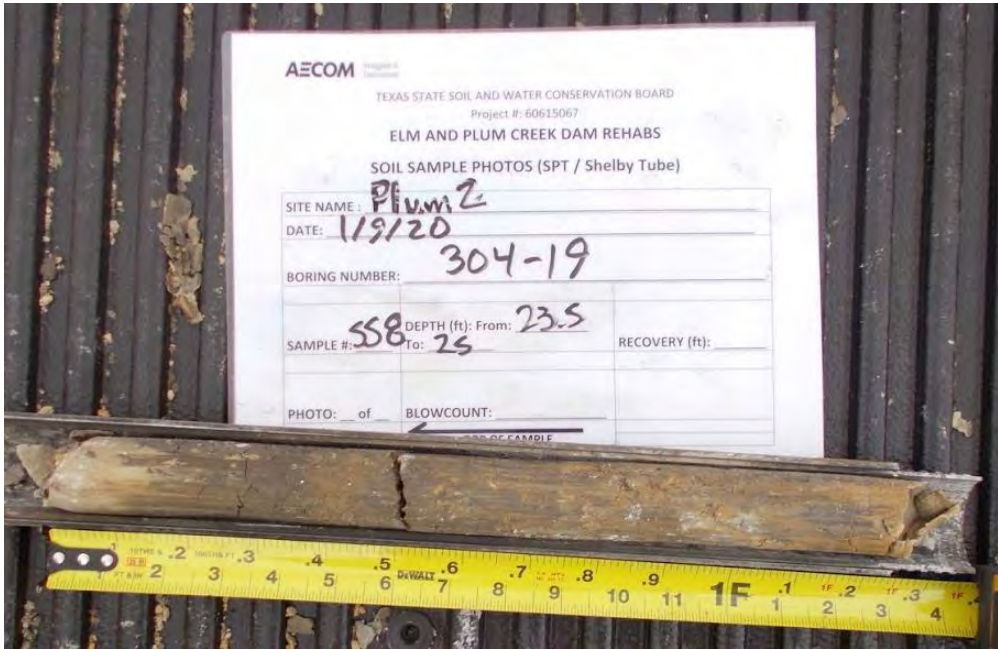
Photo No. 10	Date: 12/9/19

Description: Boring 304-19. SS-8. Depths ~ 23.5-25 ft

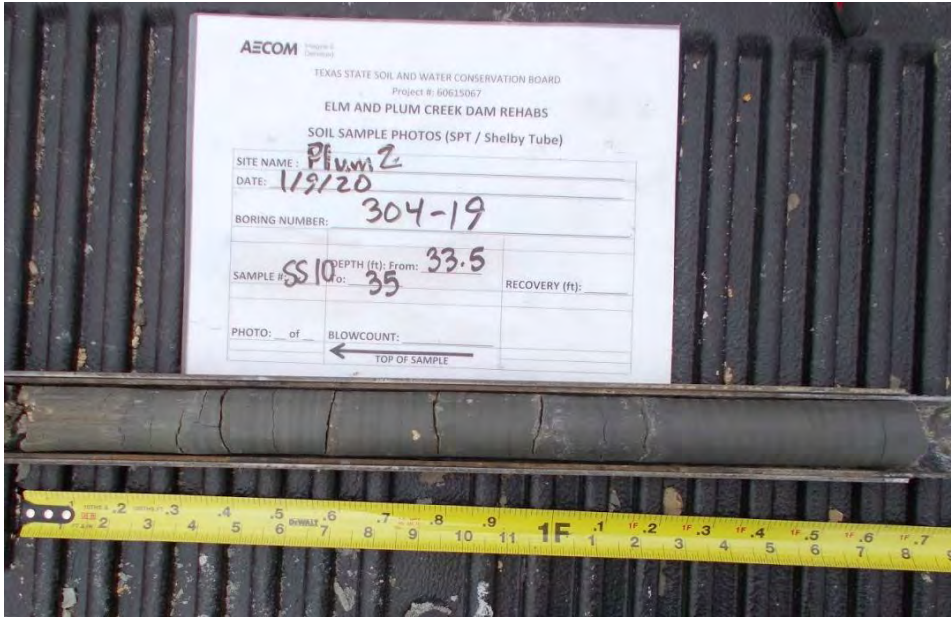
Photo No. 12	Date: 12/9/19

Description: Boring 304-19. SS-10. Depths ~ 33.5-35 ft

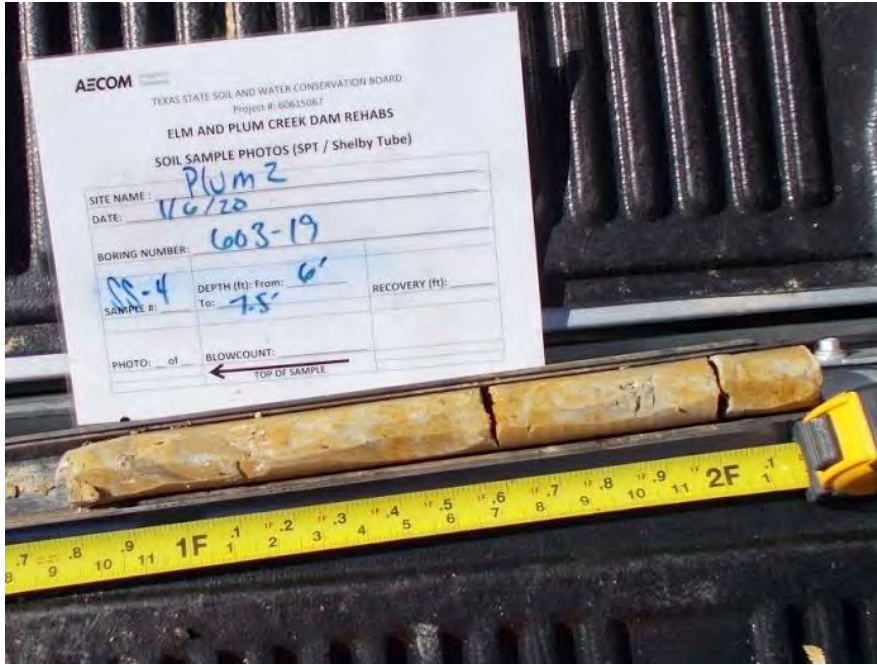
Photo No. 4	Date: 12/9/19

Description: Boring 603-19. SS-4. Depths ~ 6-7.5 ft

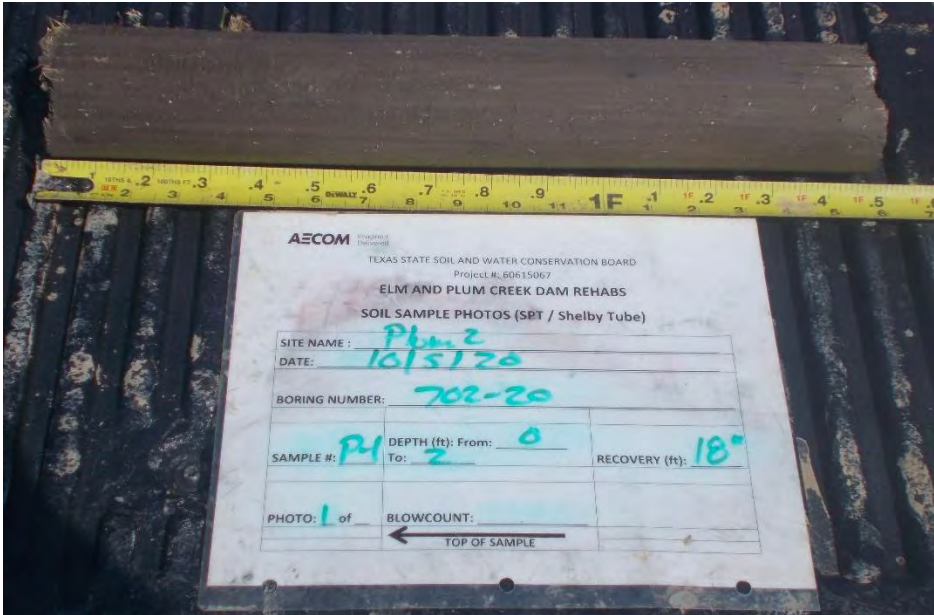
Client Name: TSSWCB		Site Location: Plum 2: Kyle, TX	Project No. 60615067
Photo No. 1	Date: 10/1/20

Description: Boring 702-20 Sample: P-1. Depths: 0-2 ft

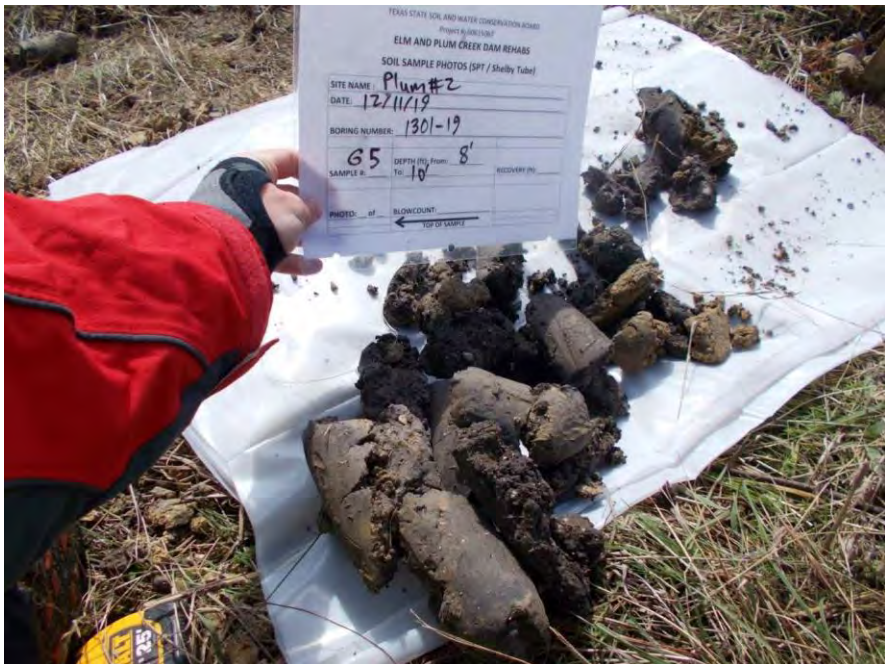
Client Name: TSSWCB		Site Location: Plum 2: Kyle, TX	Project No. 60615067
Photo No. 5	Date: 12/9/19

Description: Boring 1301-19. G-5. Depths ~ 8-10 ft
